## Tamworth

September 4th 1870

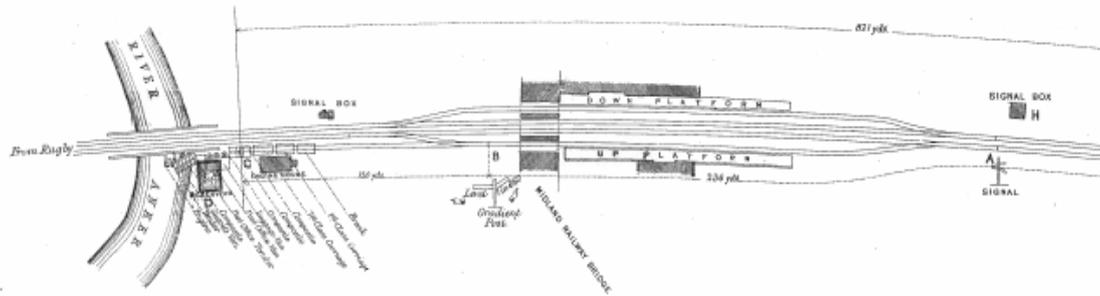
The station layout at Tamworth in 1870 was shown in the Board of Trade report thus:

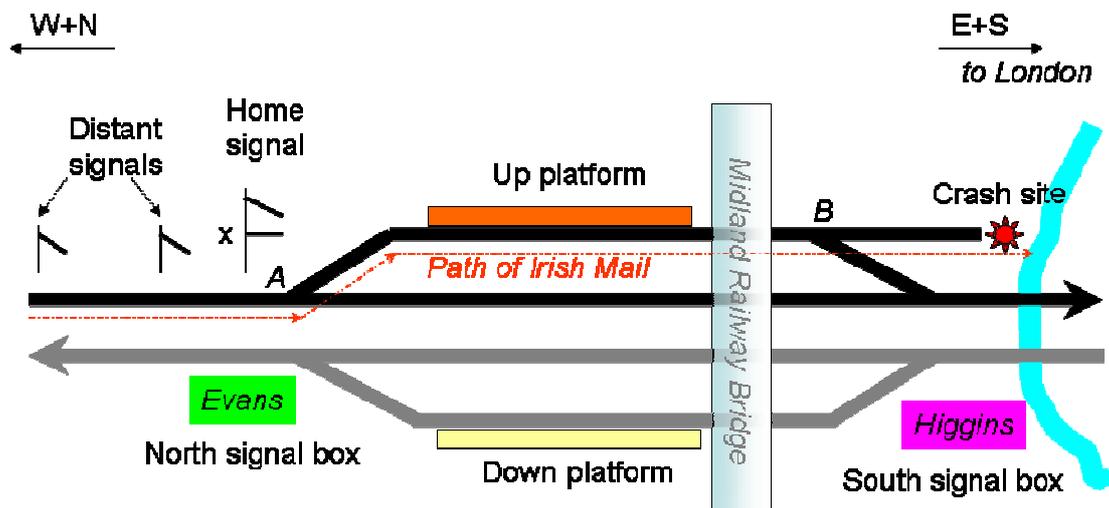
For the purposes of explaining the circumstances of the accident, the following diagrammatic representation may be more helpful. It involves a reorientation that brings the location of key features into line with a modern map of Tamworth. The station itself is oriented from west to east, with track turning away to the north to the west and to the south in the east.

A train that approached the station on the up line (from the North) passed signals on three occasions, first at the distant signals, then at the pair of home signals indicated (see the diagram). Notice that only the home signals were interlocked with the points, so that it was possible (as in the diagram) for a through train to encounter distant signals set to clear even though the points were set for the platform line, and the home signal for the main line was accordingly set to danger (as marked with an 'x' in the diagram). The enquiry highlighted the absence of other interlocking mechanisms such as would have prevented the points at A and B being configured in what the accident revealed to be such a potentially dangerous state.
