## Flat Roof Pre-access Hazard Identification Report

### 01.057 JUNCTION

Date undertaken 4<sup>th</sup> May 2023

01.057 Junction building, Central Campus

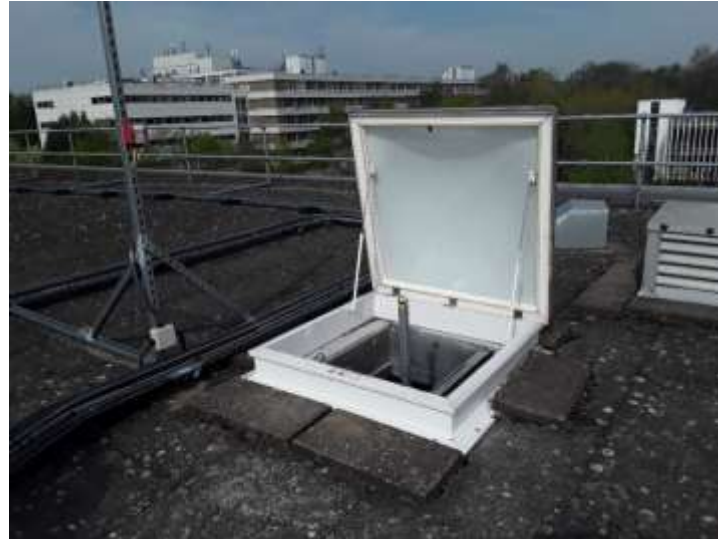
9.8 The plant room ceiling before exiting out of the roof hatch onto the roof is quite low.

Hatch out onto roof

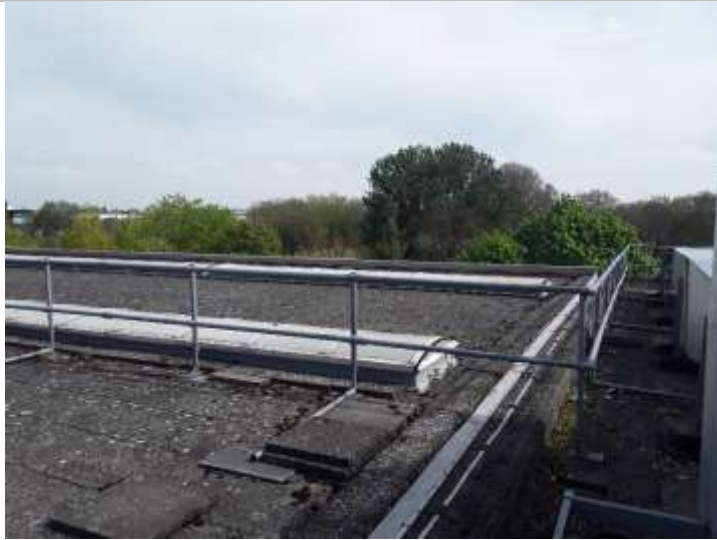
General edge protection around parts of roof

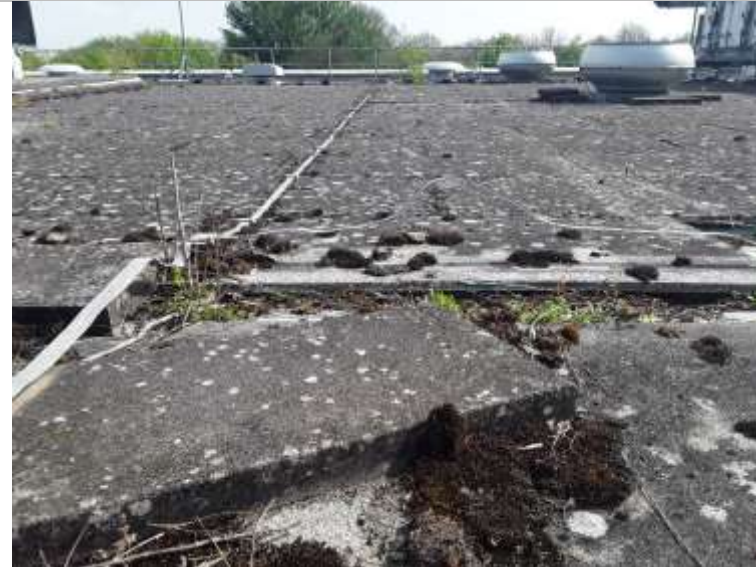
**7.1** Slips, trips, and falls around the site. There are uneven and missing slabs from the roof causing trip hazards. Numerous cable trays across the roof at floor level

Typical loose slab along with raised lightning conductor cable

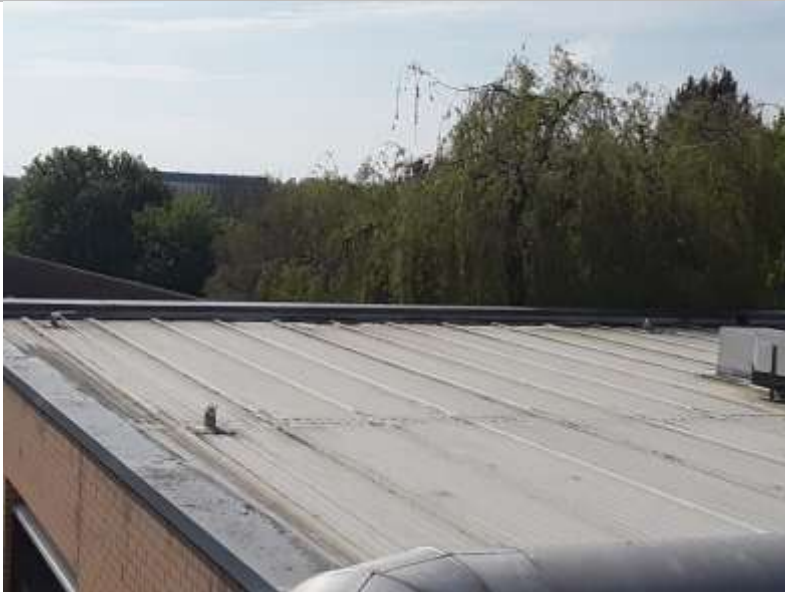
9.6 Part of the roof has no edge protection however, there are man safe/latch line systems in this area that must be used. The Competent Person must have evidence of training in the use of man safe systems and the correct personal equipment for their use. The Competent Person must have assurance that the lines have been inspected and certified safe to use before latching on to them.

Area of roof without edge protection

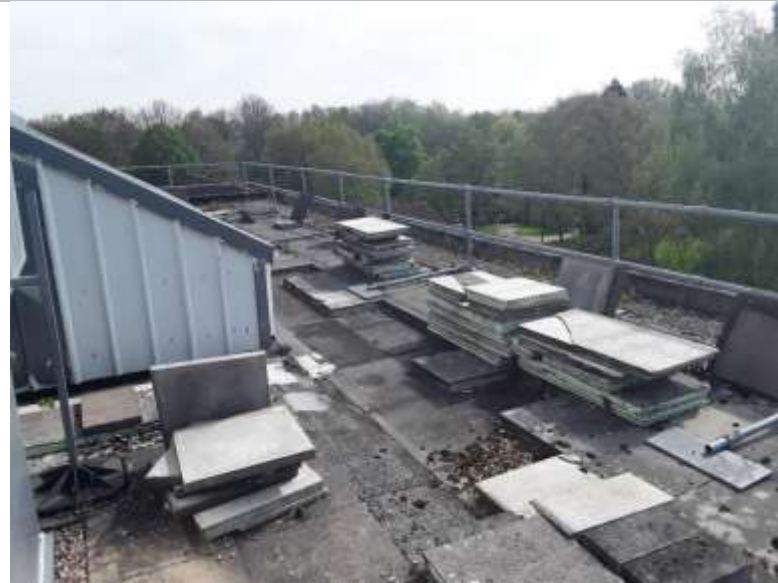
9.3 Various items are discarded on the roof including slabs and building materials which will cause a trip hazard or in high winds may take off the roof.

Example of waste and materials gathered

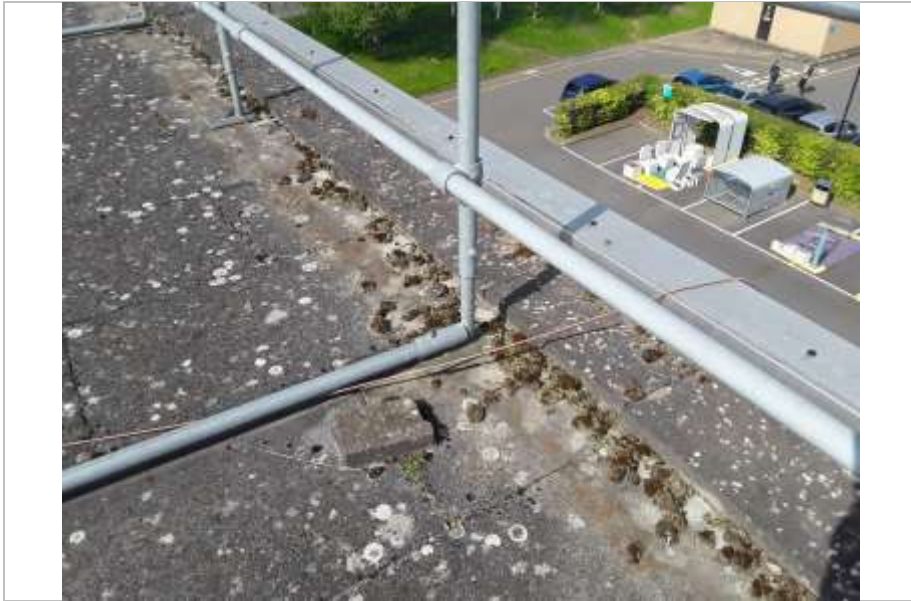
9.4 Some of the edge protection upstands are not weighted or anchored down, leaving questions about its integrity and sturdiness.

Edge protection supports not anchored
