Kirby Hall, Northants

The Evidence of the Masons'  
Marks

Jennifer Alexander 2012

August 2012

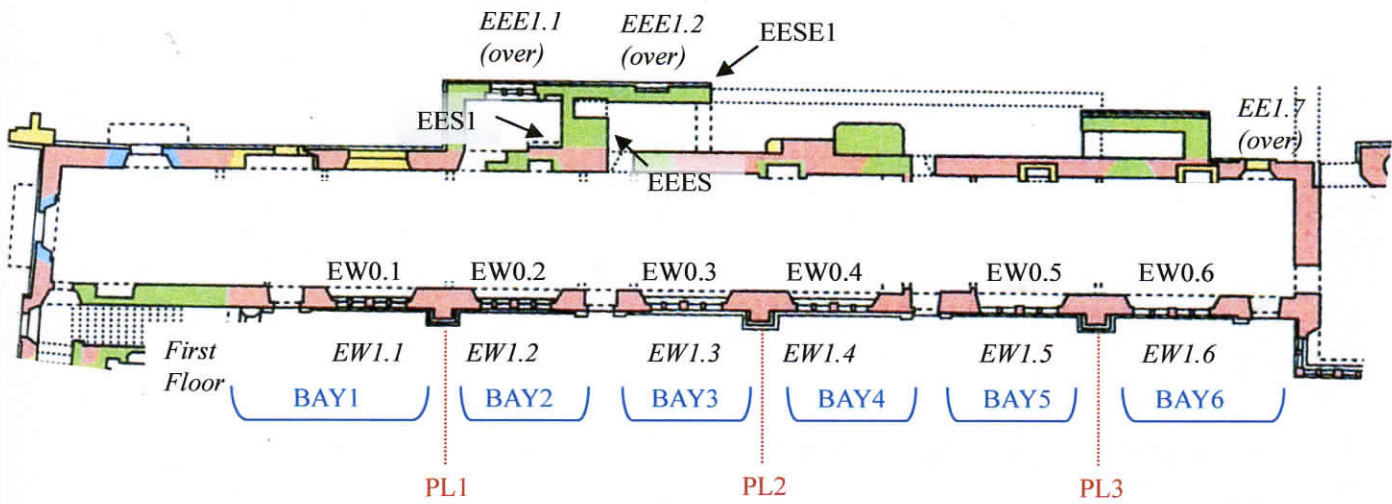
EAST RANGE SITE CODES

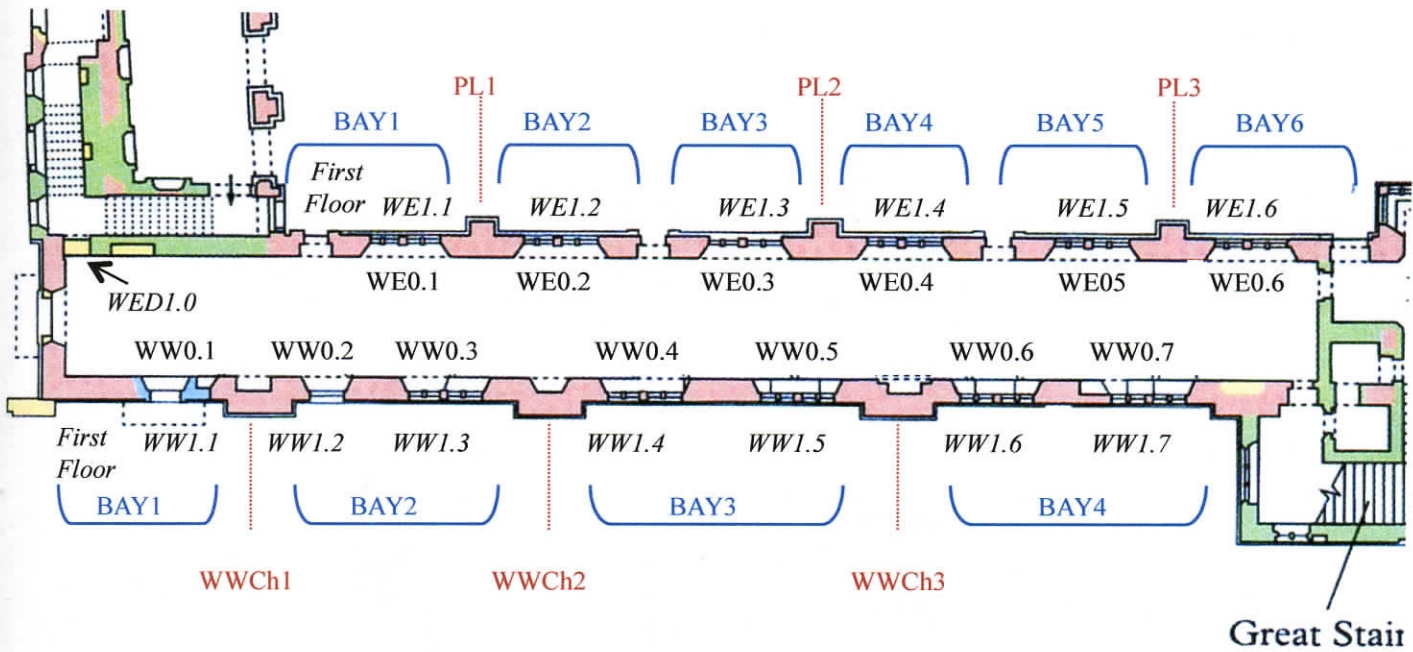
WEST RANGE SITE CODES

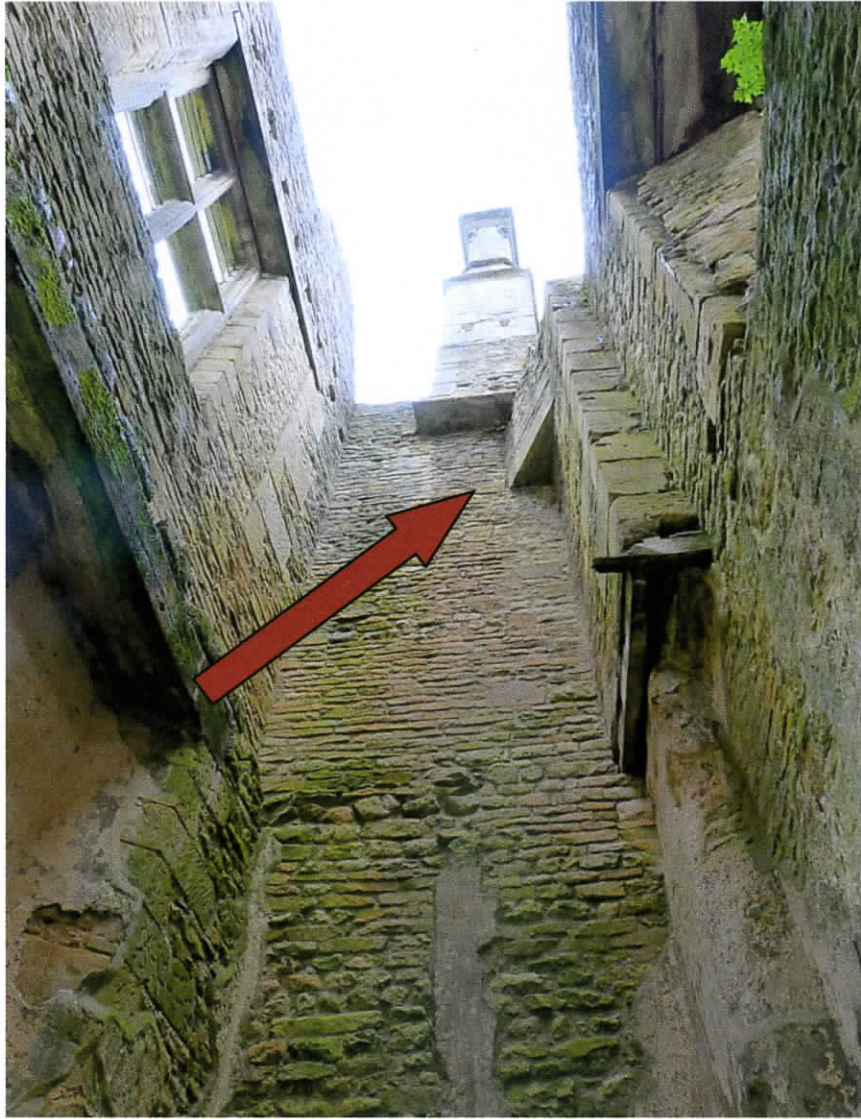
Fig. 3 East Range,  
south end, mark 4q7  
on site EES1

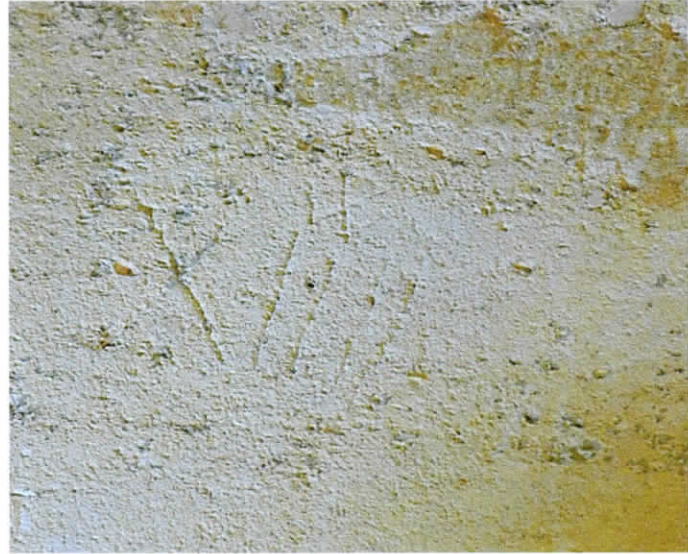
Fig. 6 Marks 11x14, 8gv8 and 7gv14 from the porch

Roman numerals are frequently found at other sites where it has been observed that the marks rarely conform to the practice of putting I before a V or X for the numbers 4 or 9, and instead IIII or VIII is used for clarity, and to avoid confusion with the numbers 6 and 11. The same occurs here, and it is assumed that IIIV is meant to be read as 8, and not as an unusual way of writing 2. There are gaps in the sequence which starts at 4, and it is only continuous from 7-15. It is therefore unlikely that there is any numerical significance in the sequence (Fig. 6).

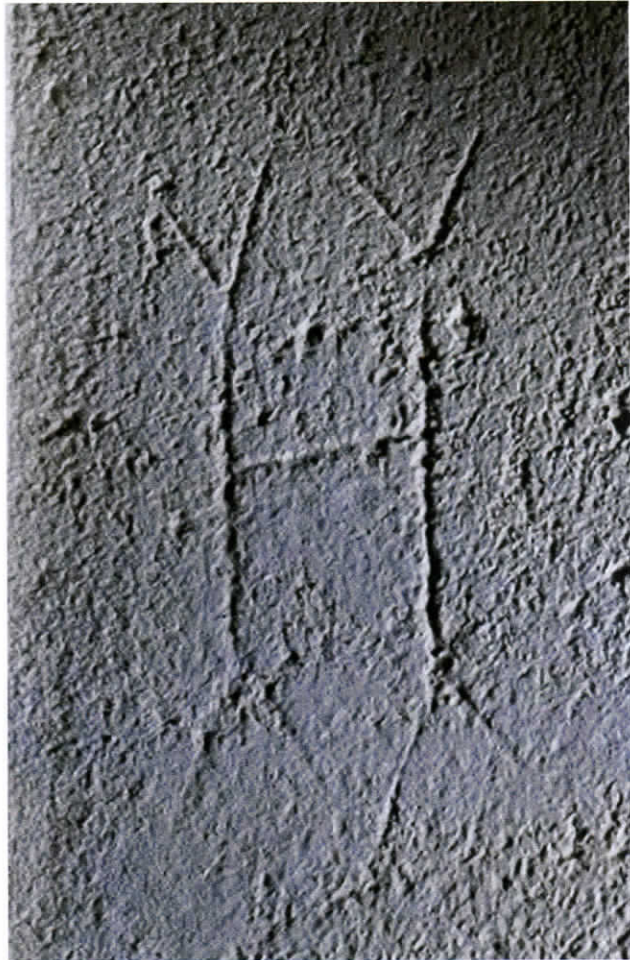
Fig. 7 Marks 11h1, *upper*, and 11h2, *lower*

The mark 11h1 is only found on moulded work and resembles 11h2 which is found on the embrasures of the W range windows exclusively and it raises the question of the significance of the differences between marks since both marks have a similar form. 11h2 is a small mark with the main strokes deeply cut and the additional strokes are a minor element of the mark. By contrast 11h1 is invariably lightly incised and the end strokes are proportionally larger (Fig. 7). Since the marks were cut freehand it is to be expected that there will be variation in their scale, and not all blocks of stone have the same cutting properties, so marks will not always be cut to the same depth or in quite the same way. The consistency of the difference between 11h1 and 11h2 would lead to the conclusion, however, that either they were the work of different masons, or that they belong to different periods. 11h1 can also be found at a number of other sites in the region, in buildings that are dated from 1578 (Rothwell Market House) to 1622-24 (Apethorpe Hall) whereas

11h2 has only been found at Kirby and it would therefore seem that the two marks belong to two different masons.

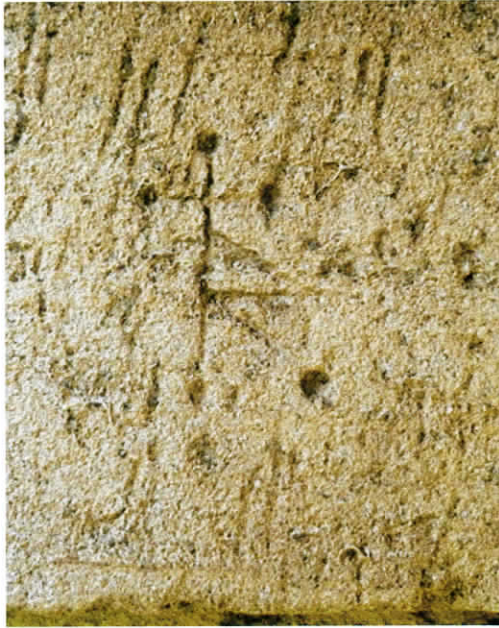
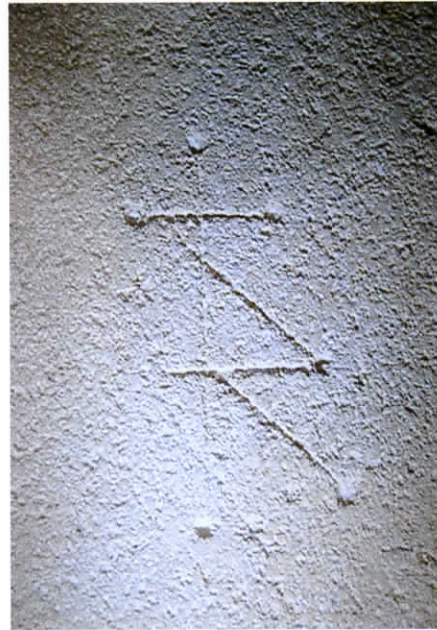
a) Mark 5t6 on the E gate at Kirby Hall, *left* and at Deene Park, *right*

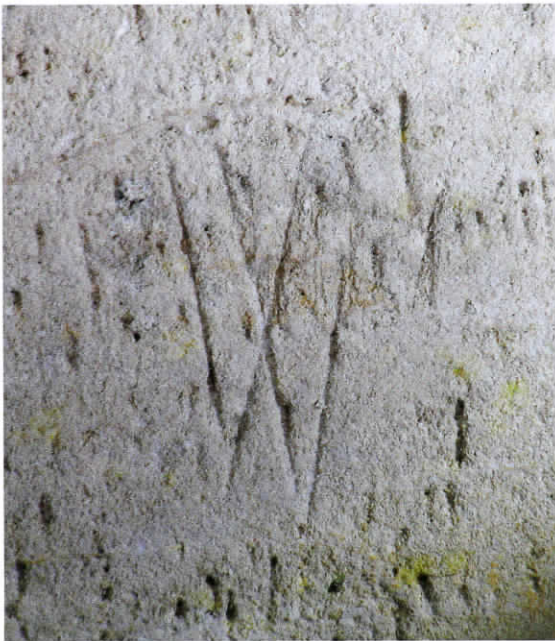
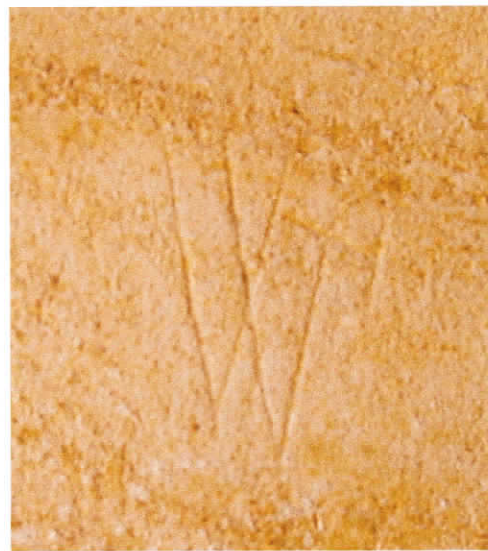
b) Mark 6w10 on the W gate at Kirby Hall, *left*, and at Apethorpe Hall, *right*

As noted above, there is a particular connection with the 1622-24 range at Apethorpe Hall. Marks 11h1, 13h1, 5t6, 6a30 and 6w10 are shared between the two, and the less-distinctive marks 3b10, 3h1, 4m1, 4w2, are also present at both sites. The quarry-master Thomas Thorpe has been linked to Apethorpe and it seems probable that his masons were also involved at Kirby. This would be a fruitful line of enquiry to pursue, in which other buildings from the period that used the stone quarried in the region might also be included.

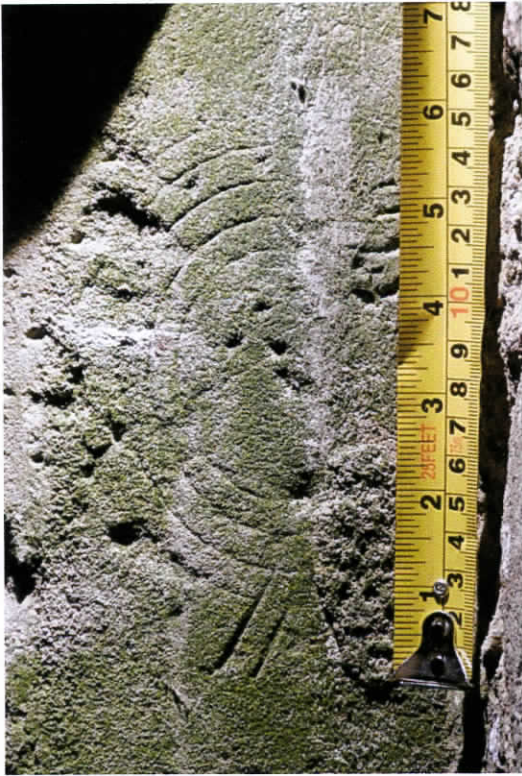
Fig. 9 Geometric drawings from E range window EW0.5, *above*, and SW range passage, *right, upper and lower*
