who built
Beverley Minster?

edited by P.S. Barnwell
and Arnold Pacey

Masons' marks and the working practices of medieval stone masons

Jennifer S. Alexander

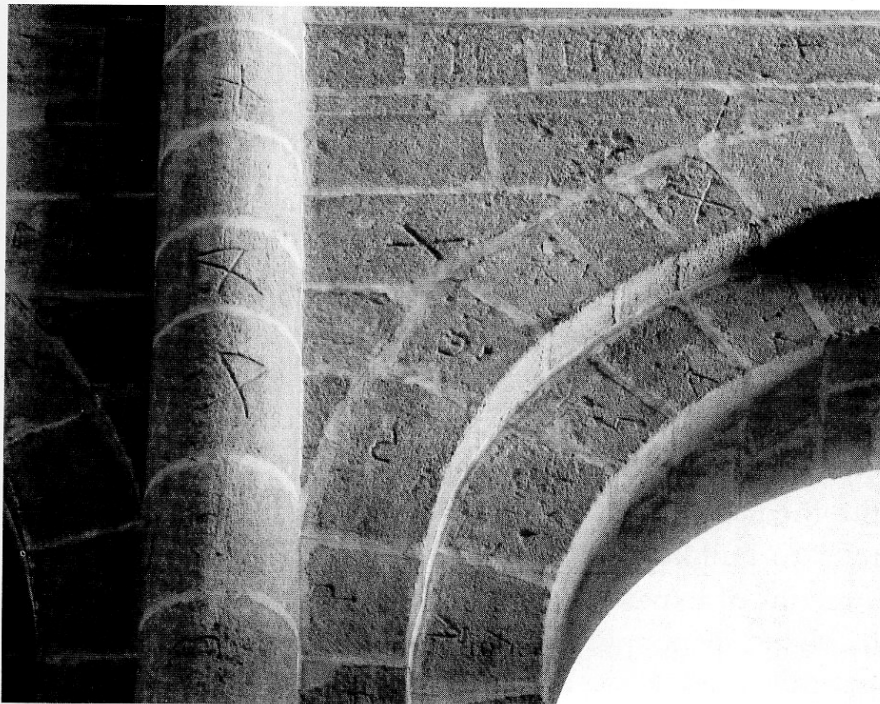
2.1. Masons' marks on the vaulting shaft, arch and spandrel wall of the transept arcade in the cathedral of Santiago de Compostela, Spain [Author].

Look closely at the walls of many medieval churches and, if the light is right, carefully inscribed marks can be seen (Fig. 2.1). They are masons' marks and they were made by the stone masons who cut the blocks that make up the walls, piers, arches and windows of the churches. Beverley Minster is especially prolific in such marks.

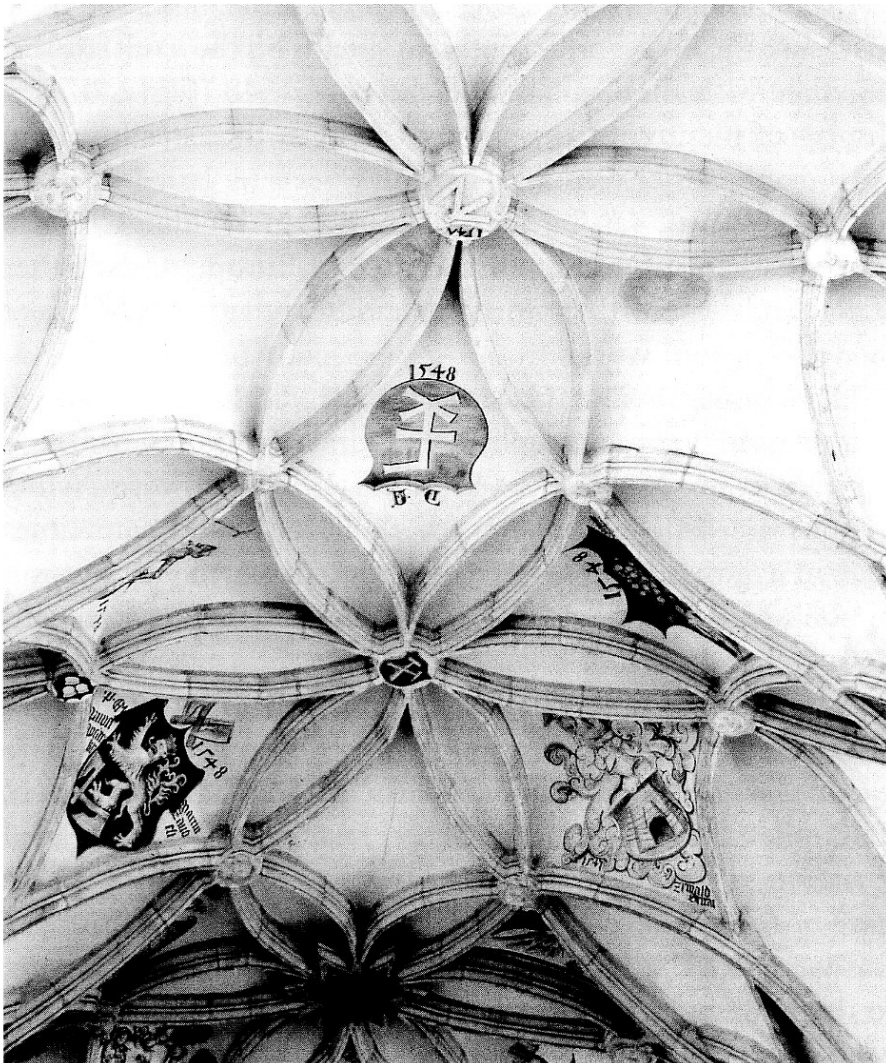
2.2. A vault at Kutná Hora, Czech Republic. The boss at the top of the picture and the painted shield both display masons' marks [Author].

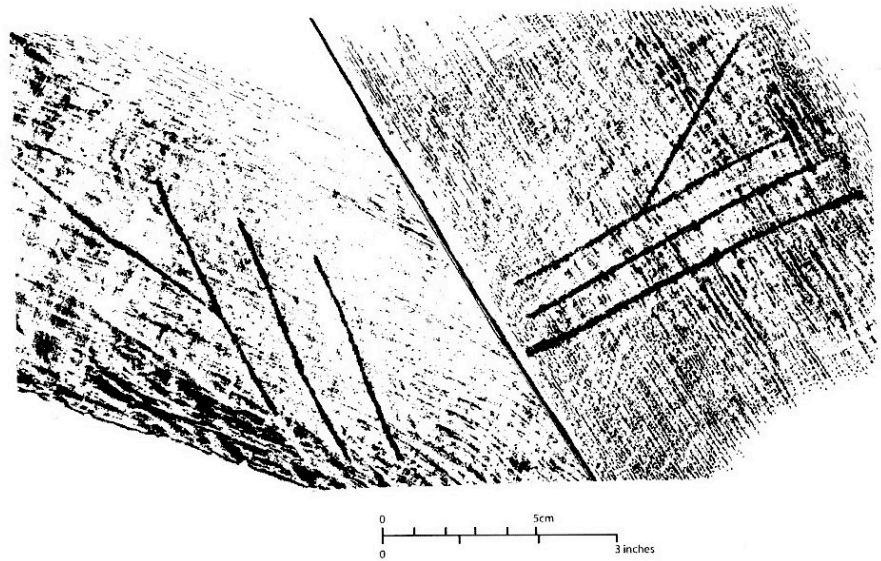
2.3. Carpenters' numbers on either side of a joint between a rafter and a brace in the roof of Beverley Minster. The numeral is a Roman III with an additional tag that the carpenters used to distinguish joints on the north side of the roof from those on the south side [*Alison C. Armstrong*].

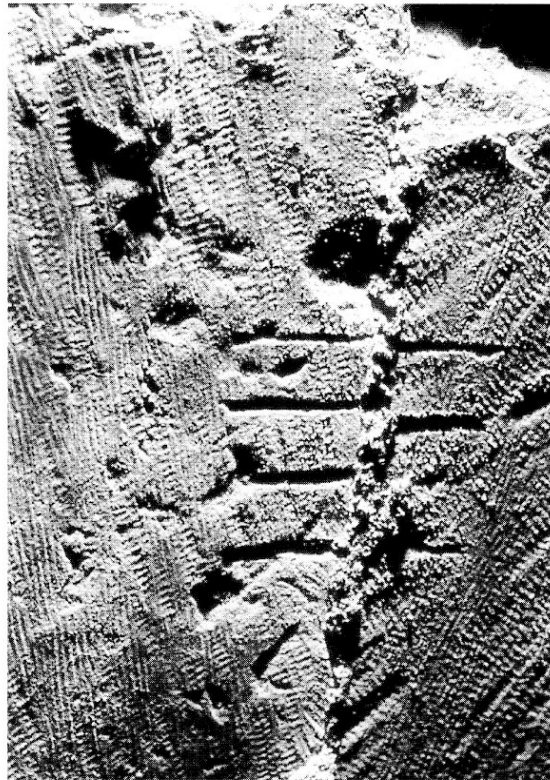
2.4. Joint marks on blocks of stone used in a newel stair of the Lincoln Cathedral Angel Choir, mid-13th century [*Author*].

Quarry marks are unlikely to survive the process of cutting up the stone and dressing it for use in the building, and indeed their purpose is served once the block has been delivered to site. Marks of the second category can often still be seen on the faces of the stone since they were part of the process of construction. This type is the assembly mark and it enabled complex sections of things like doorways, niches or other such work to be built up in the correct order. The marks form

a sequence in many cases and they are often still visible in the finished building. Sometimes the sequence was based on a version of Roman numerals. At other times a domino system was used in which the end of one block had the same symbol as the end of the next block, which in turn had a different symbol on its other end to relate to the next one.

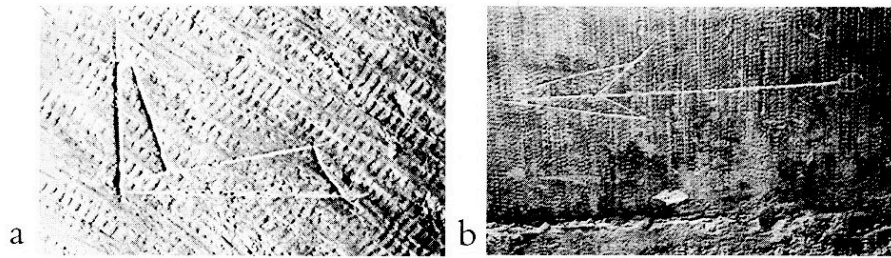
2.5. Masons' marks from the 13th-century Angel Choir at Lincoln Cathedral. a: apparently a drawing of a mason's square; b: in the form of an arrow [Author].

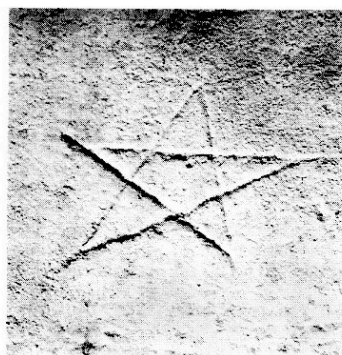
2.6. Mark in the form of a star at 'the barn', Kenilworth Priory [Author].

that this was not true, but it is a view that is still sometimes voiced. Marks from Bronze-Age Knossos (c. 2500 B.C.) look very much like marks from 13th-century Southwell Minster and coincidences are very common. An unwary collector of marks could outline a career for the mason whose mark was a five-pointed star that began at Winchester in the 1080s and ended at Apethorpe Hall, Northamptonshire in the 1620s, taking in Buildwas Abbey, a building at Kenilworth Priory known as the barn, and Santiago de Compostela and Lincoln cathedrals along the way (Fig. 2.6). Clearly this cannot be true.

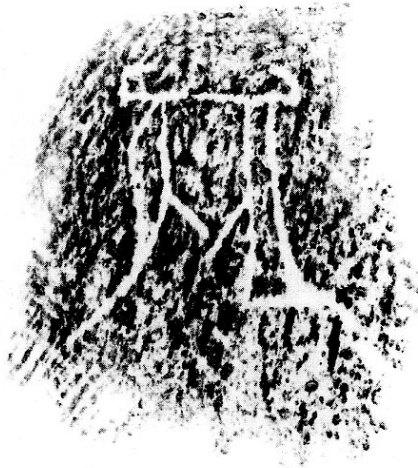
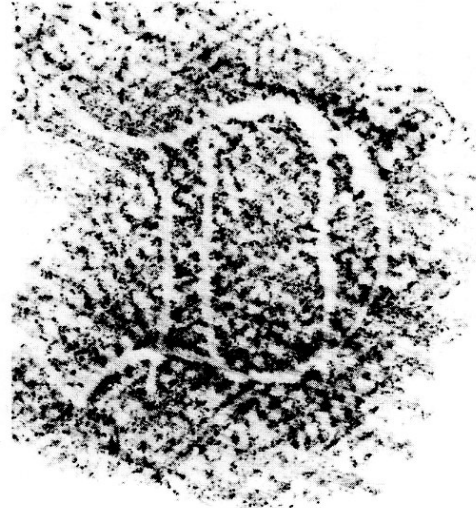
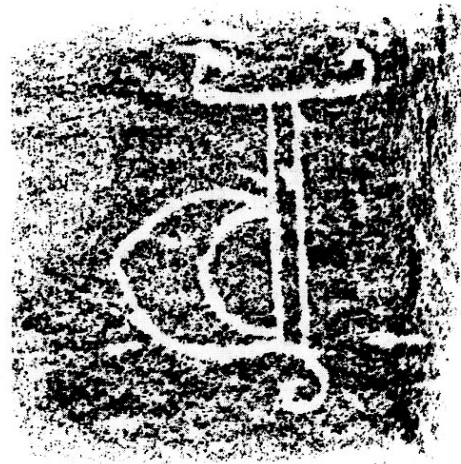
2.7. Lombard-letter marks. Above left and right: Lincoln Cathedral. Lower right: St Mary, Nottingham [*Author*].

Nottingham, St Mary, are similar to Lombard capitals, found in the 13th century (Fig. 2.7), and marks at Ludlow, King's College Chapel, Cambridge, and York are well-drawn versions of the later *textura* letters (Fig. 2.8).¹¹ Although similarities with letters do not date the marks precisely they do provide some indication of period since these letter-forms were in use at particular times. They can also tell us something about the masons who used them, but not necessarily whether they were literate. The marks always occur alongside the more usual line-based marks, so it would be unlikely that one or two masons in the team were more literate than the others. It may have been the case that the letter refers to the mason's name and that he was shown it and learned how to cut it. Fotheringhay church has a series of marks including a beautifully cut *textura* 'h'. The church nave was built in the 15th century by a master mason called William Horwood and it is possible that the mark is his, although it is found on plain stonework which he would have probably assigned to an ordinary banker mason. Perhaps a select team of his masons used it.

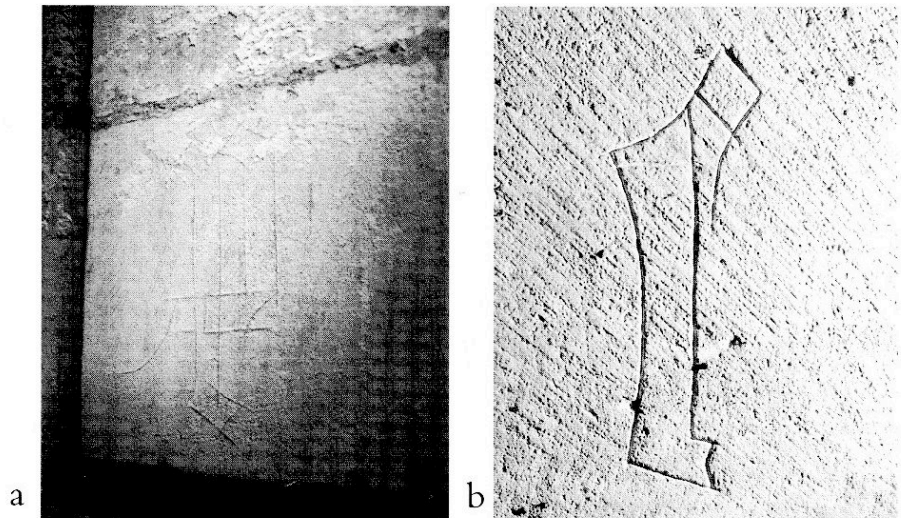
2.8. Textura-letter marks. a: tomb of Archbishop Blowet († 1423), York Minster. b: 14th-century work at Lincoln Cathedral [Author].
