# ELECTRICAL MACHINES

# FAULTS IN MEDIUM VOLTAGE ELECTRICAL MACHINES

# WORK UNDERTAKEN ON WINDING DEGRADATION

Investigation of thermal degradation of Polyamide-Imide (PAI) insulation material

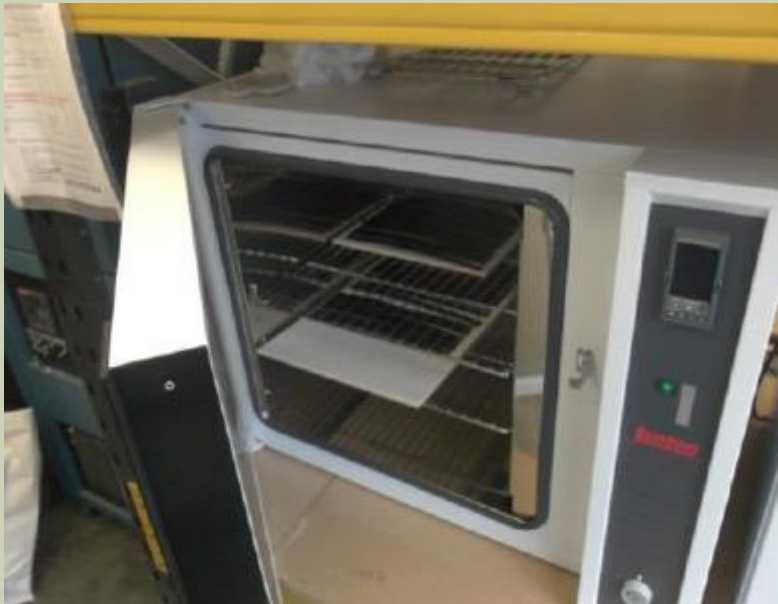
One of the six identical ovens with samples inside

Heated to 200 C, 215 C, 230 C, 245 C, 260 C and 275 C  
Time: 100 hrs, 200 hrs, 400 hrs, 800 hrs and 1600 hrs

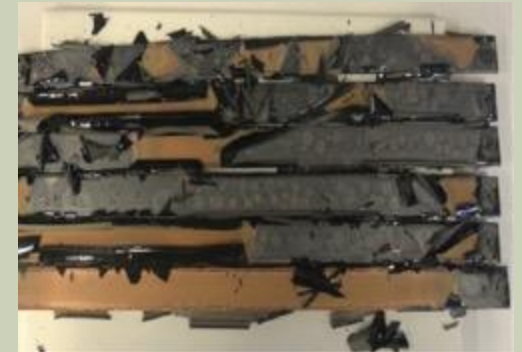
Catastrophic insulation failure of samples at 260°C after 1600 hours

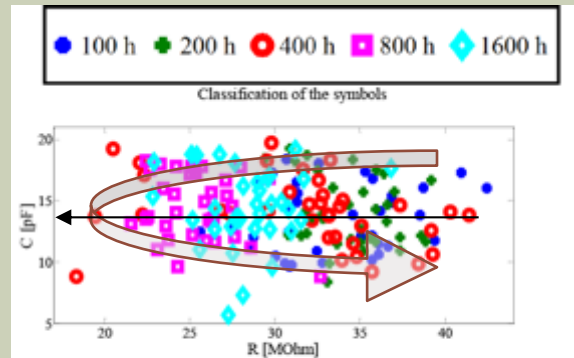
Fig. 1 Scatter plot of the samples measured capacitance versus resistance at 200°C.

- Capacitance does not have an observable trend effected by aging during 200 °C & 215 °C tests
- Insulation resistance drops first and then increases:
  - 200 °C – drops for 800 hrs followed by an increase
  - 215 °C – drops for 400 hrs followed by an increase
  - 230 °C – drops by 50% for 400 hrs followed by an increase
- Capacitance drops by 38% from 200 hrs to 800 hrs

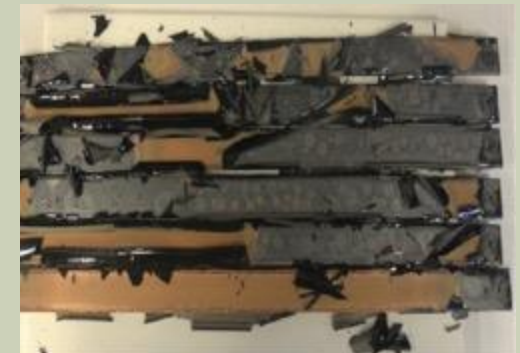
Catastrophic insulation degradation of samples at 260°C after 1600 hours
