WORK PACKAGE 2.2

ELECTRIC

MACHINES

Thermal Accelerated Aging Experiment

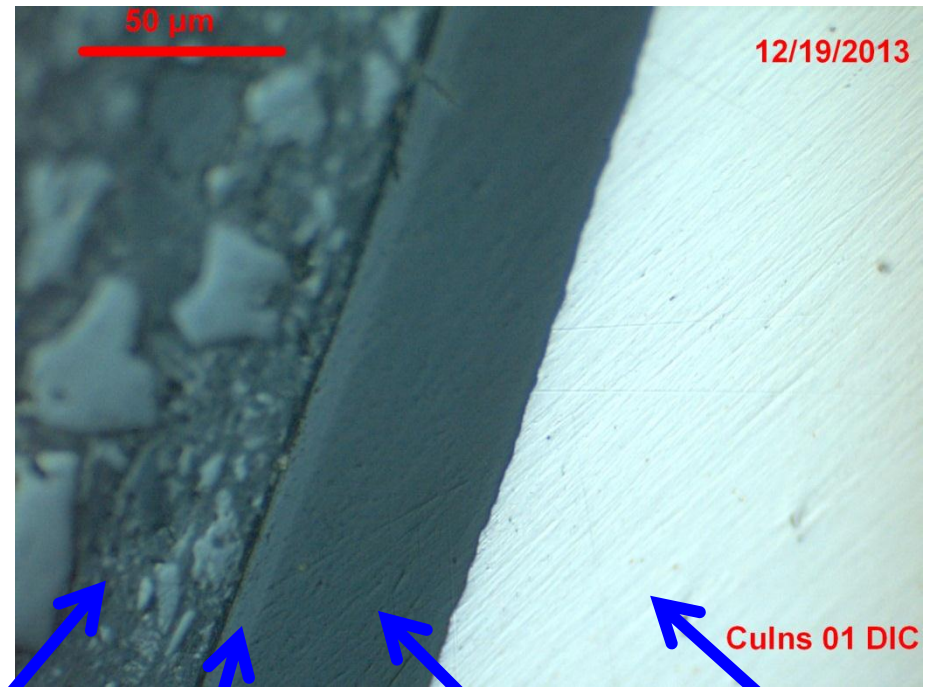
Conductor and Insulation Cross-section

bakelite
encapsulation

polyamide-
imide

polyester

copper

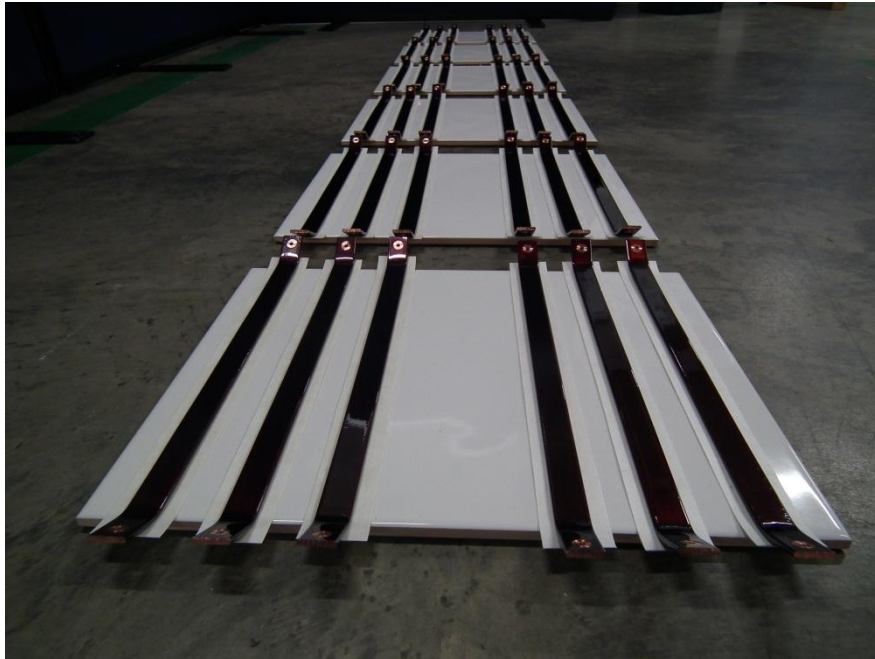
Sample preparation

- **Aim:** analyse insulation properties (roughness, FTIR, impedance) over time, at different temperatures
- Samples held at temperature for 100 hours (longer, later)

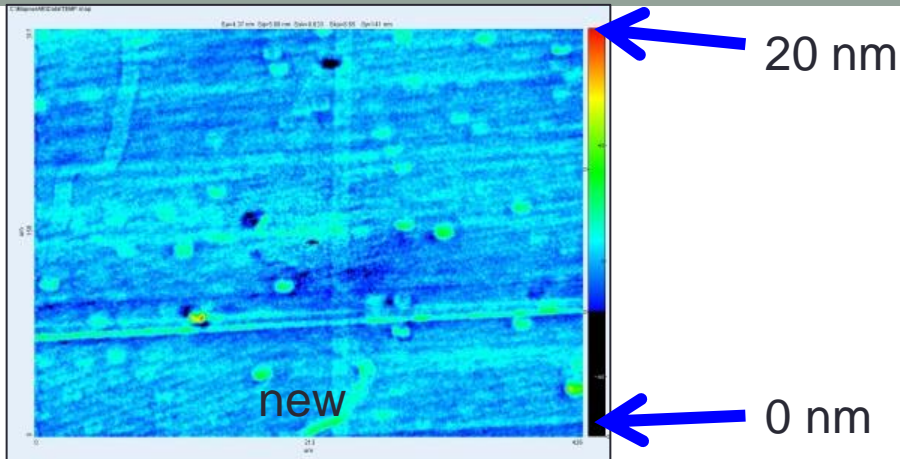
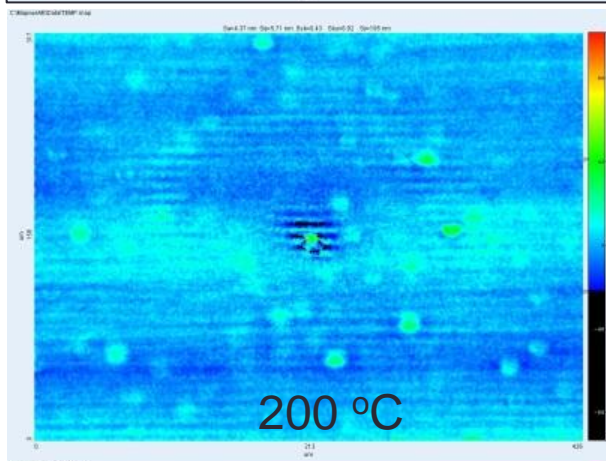
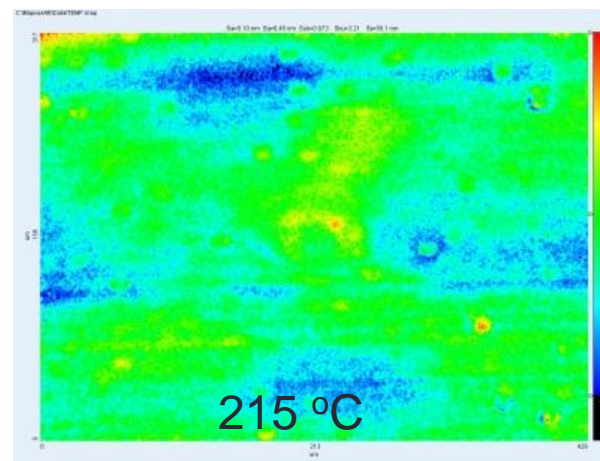
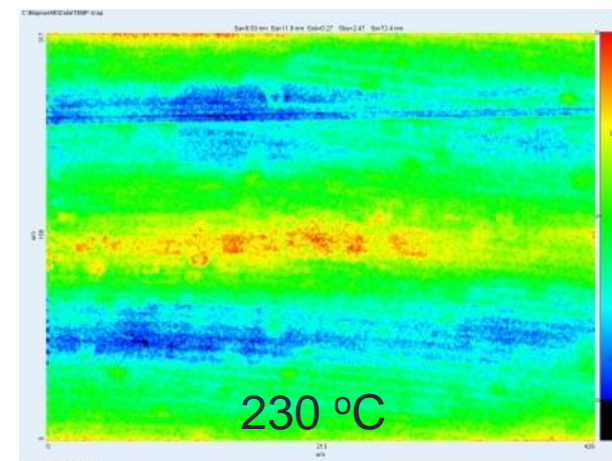
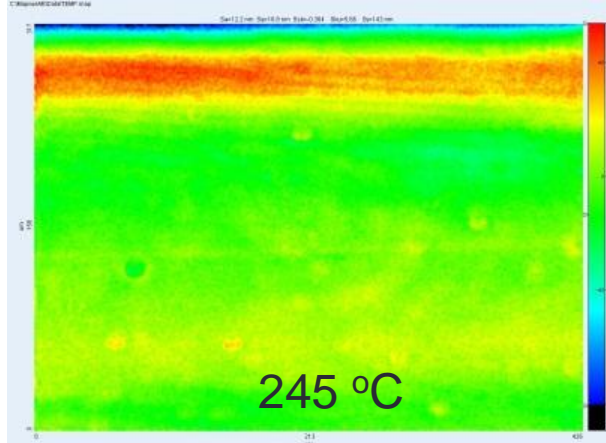
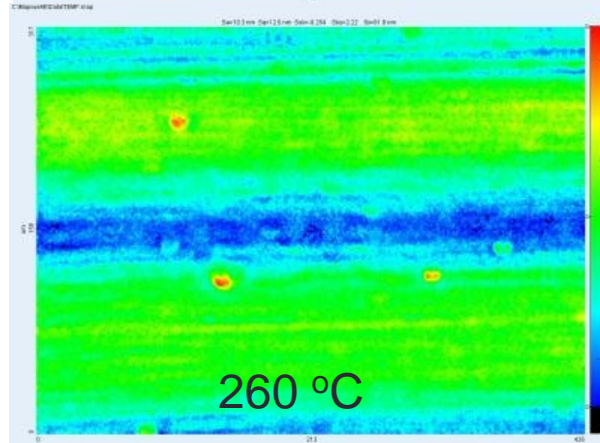
Surface roughness using MicroXAM

Samples are 317 x 421 μm

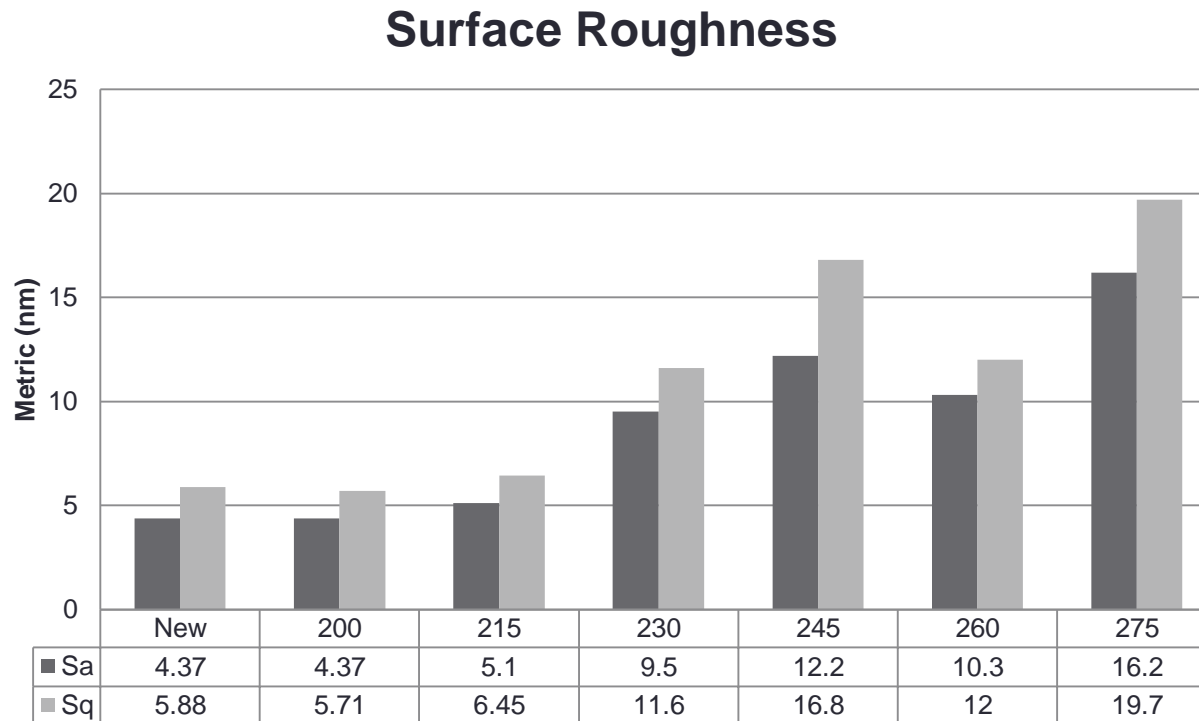
Surface roughness profiles

- The Roughness Average Sa
- The Root Mean Square (RMS) roughness Sq
- *→ conclusion: (irreversible?) changes to material properties with temperature*

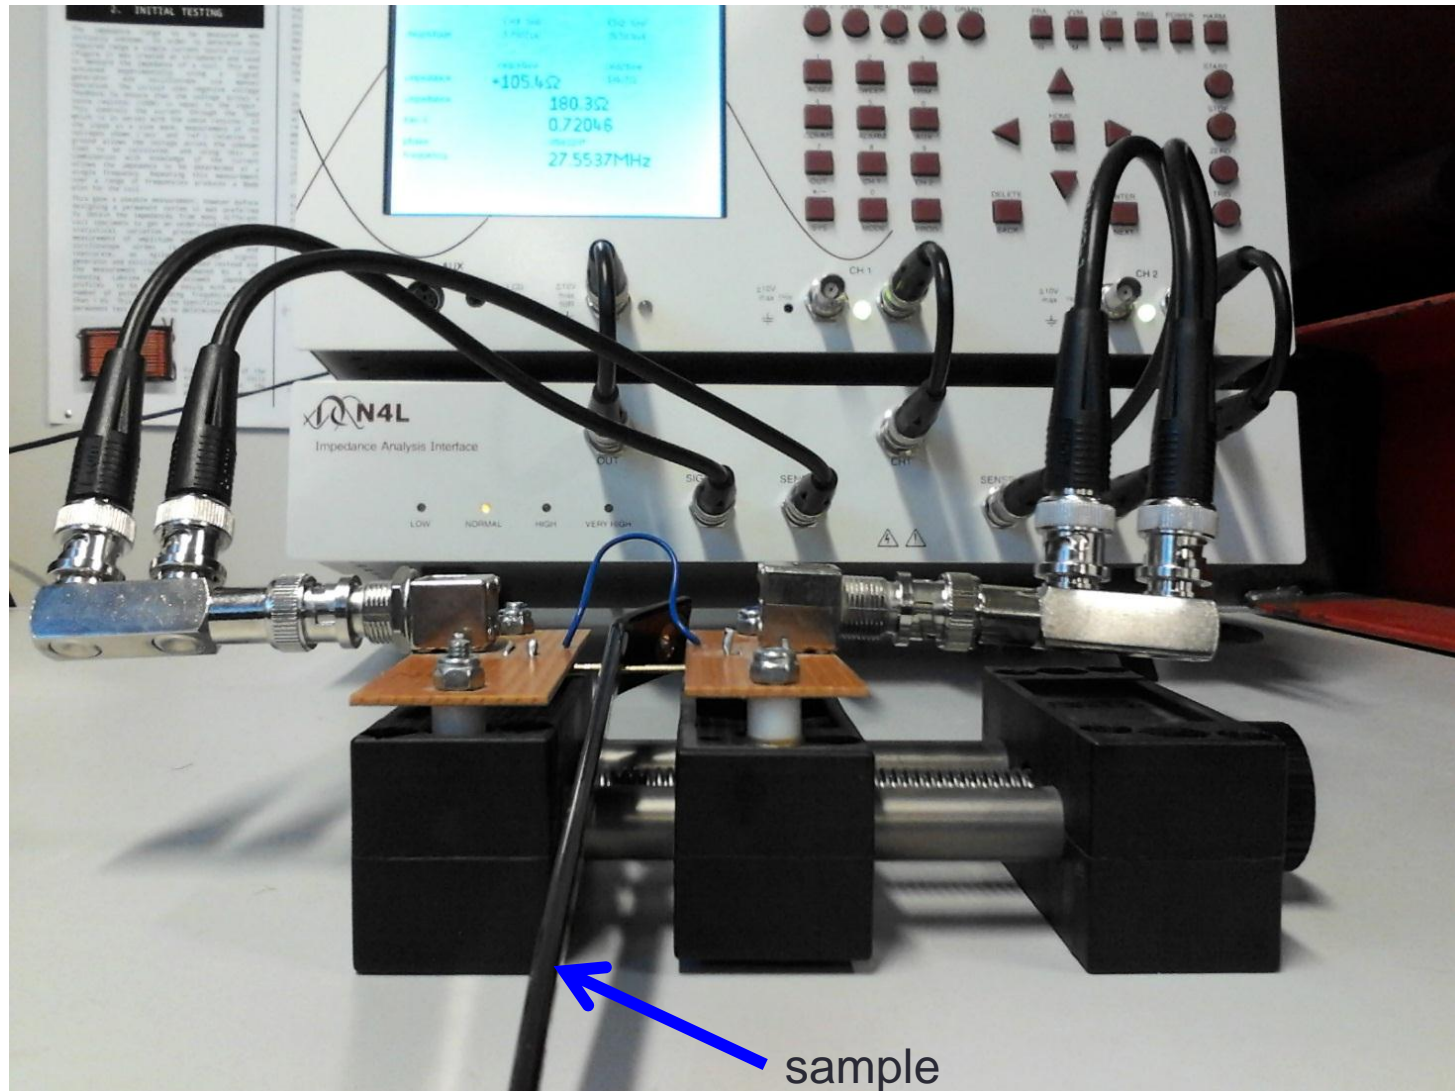
Capacitance Measurement Set-up

- Permittivity measurements using the parallel plate method

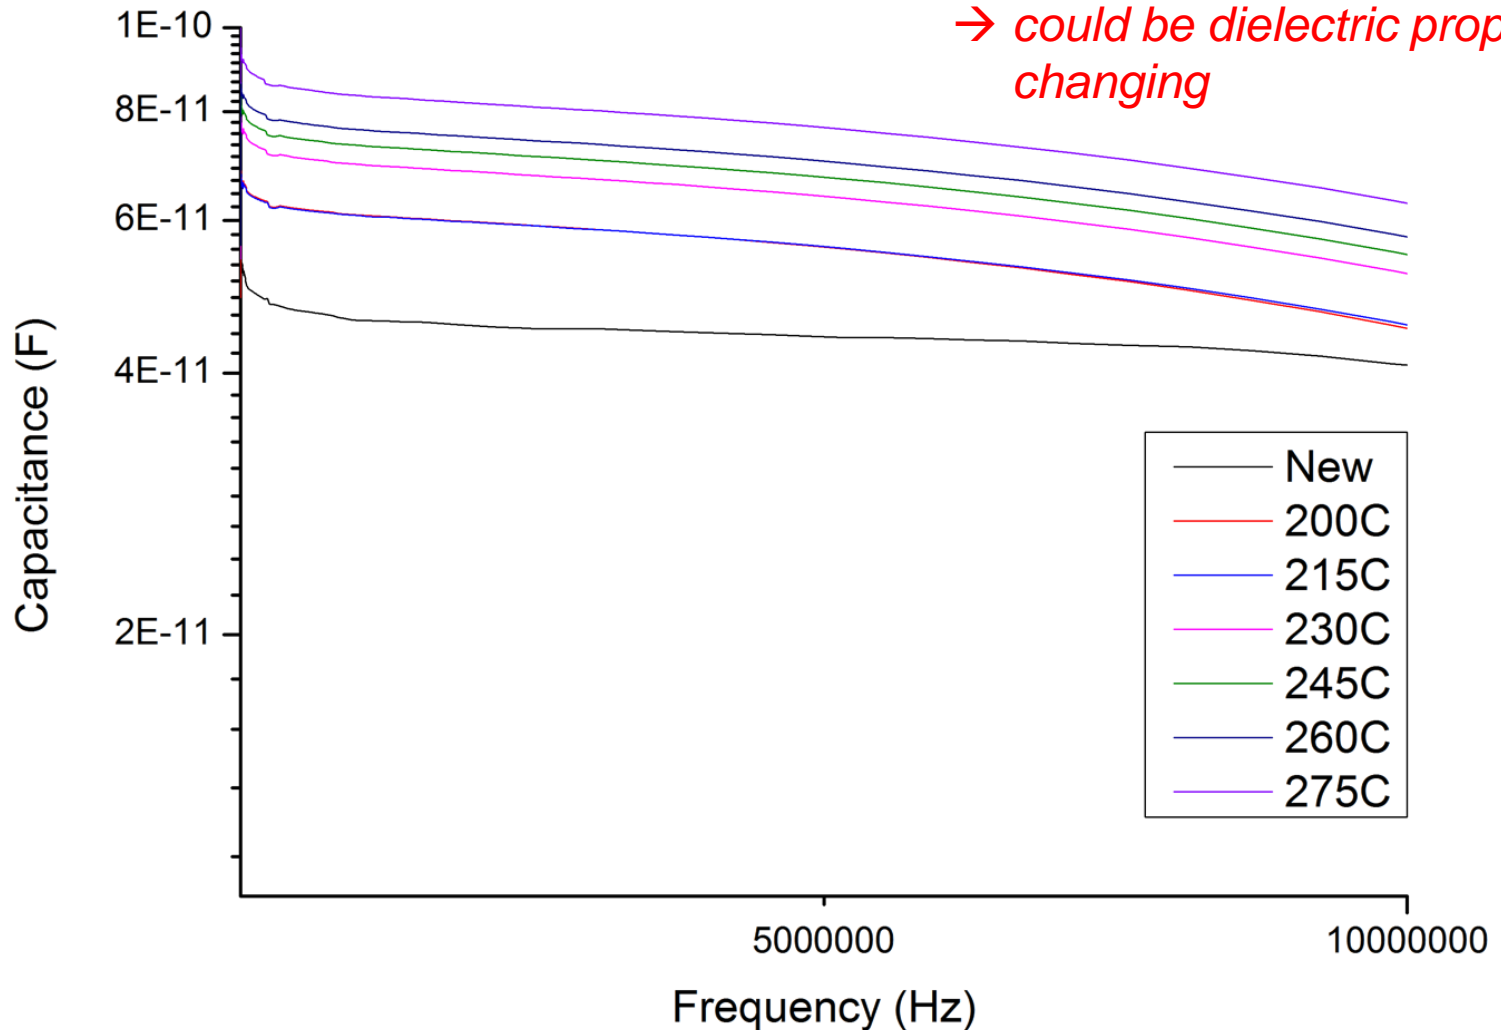
Capacitance

→ capacitance is a strong indicator of temperature history?

→ could be dielectric properties changing

- Insulation material changes after **high temperature exposure**
- Early breakdown voltage decreases at 275 degC
- Complex effect – includes drying out etc. (awaiting analysis of FTIR data)
- **Capacitance** – good indicator of temperature exposure history?
- Resistance – not necessarily?

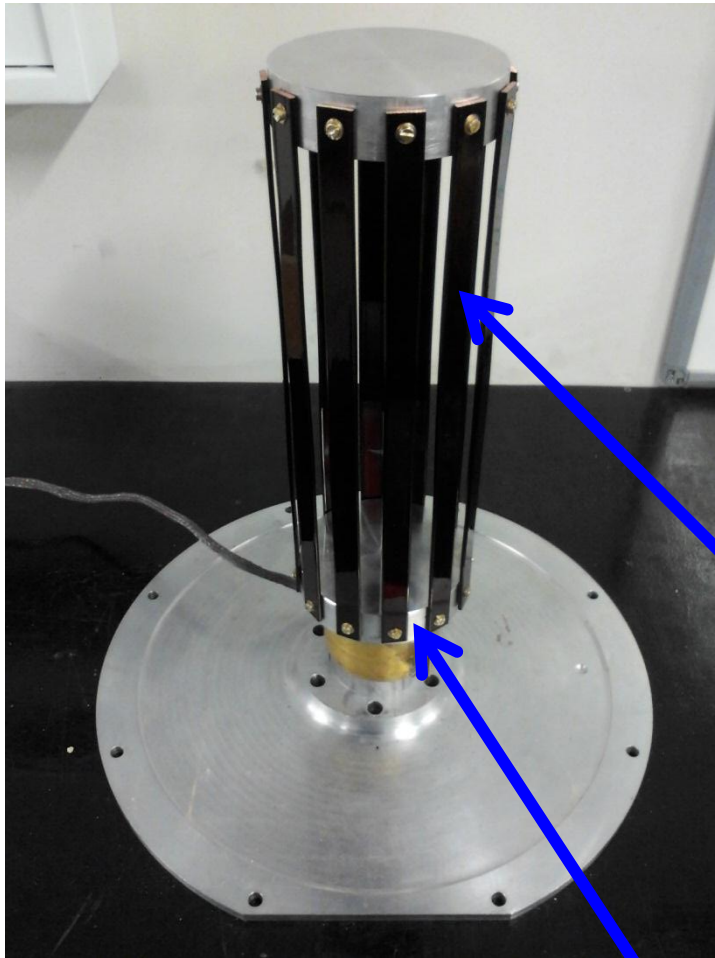
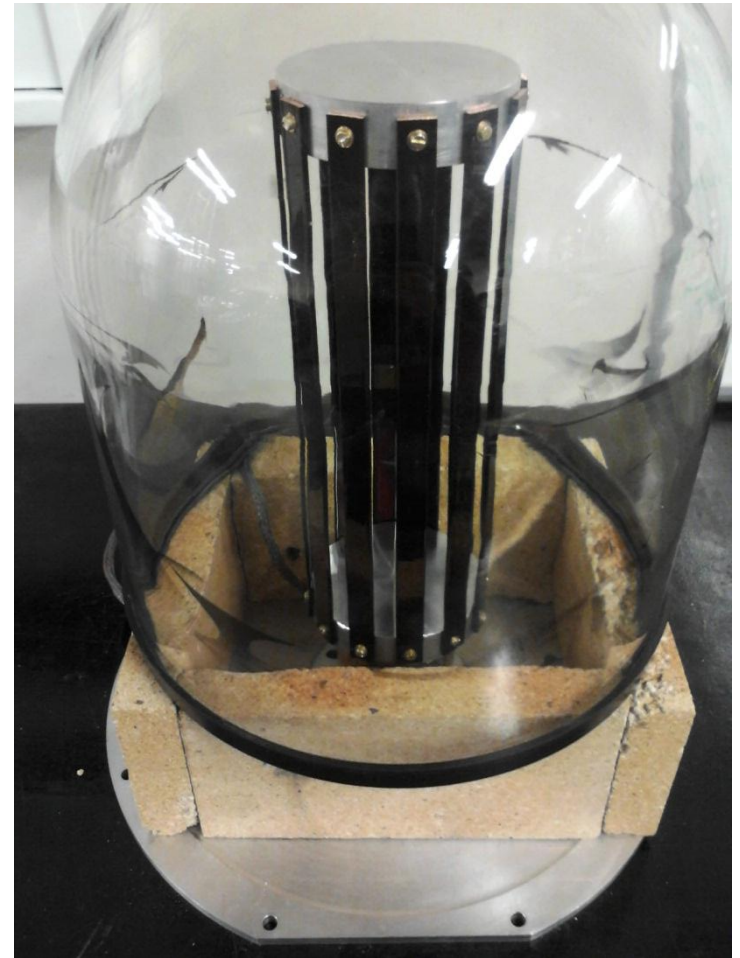
Thermal Gradient Experiment

Vertical
thermal
gradient
280-180
°C

band heater
