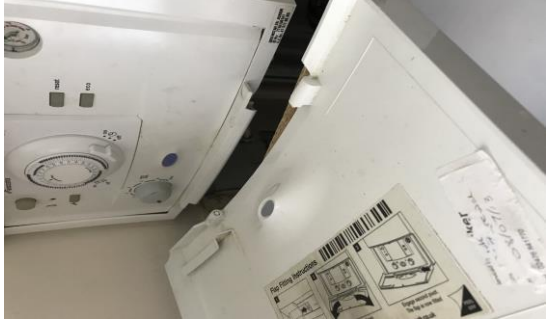
A photograph showing the control panel of a white washing machine. The panel features a circular dial, several buttons, and a prominent warning label with a barcode and text. The label includes the heading "No Hot Water" and other safety instructions.
