Gas Tightness Test									
Gas tightness test carried out (Yes / No)	Yes	Total Installation volume (m³)		Max allowable pressure drop (mbar)	4.1	Type of gauge used (water / electronic)		Tightness test result (Pass / Fail)	
Where was the Test carried out from?	ECV	Let by test duration (mins)	1	Volume smallest occupied space (m³)		Smell of gas	N/A		
Scope of work (e.g. IGE/UP/1 or 1A or 1B)	IGE/UP/1B	Stabilisation period (mins)	1	Tightness test pressure (TTP) (mbar)	21.38	CO Alarm			
						CO Alarm Installed	Date Of Expiry	CO Pass/Fail	
Installation (New / Existing / Extension)	Existing	Tightness test duration (mins)	2	Actual pressure drop (mbar)	0	Yes	07/2035	Pass	
Meter Information									
Gas Meter Present	Yes	Meter room secure	N/A	Meter room key labelled	N/A	Standing pressure (mbar)		Working pressure at Appliances (mbar)	
Meter size	U6	Meter accessible	Yes	Meter room ventilated	N/A	Working pressure at meter	21.45	18.82

### Measurement protocol

**Customer:** 36 Lakeside Strat Flat  
**Status of measurement program:** Tightness test  
**Date of measurement:** 23/05/2025 11:24:34

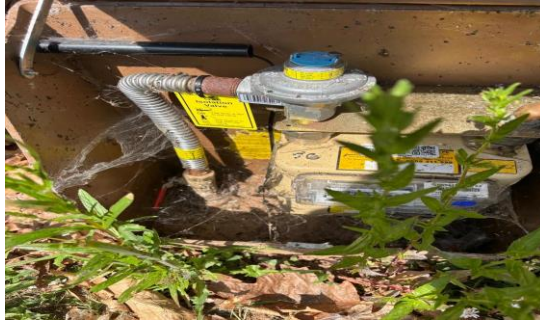
## Tightness Test Carried out from this Valve 'Label'

Measuring mode	Timed	Maximum pressure drop	4.10 mbar
Measuring cycle	20 sec	Pressure start (P_start)	21.38 mbar
Use stabilisation time	Yes	Measurement result	Passed
Measurement duration	2 min 0 sec	Start time	23/05/2025 11:22:21
Pressure probe	Neuko S10i (45884240)	End	23/05/2025 11:24:21
Fuel type	Natural gas	Duration	2 min 0 sec

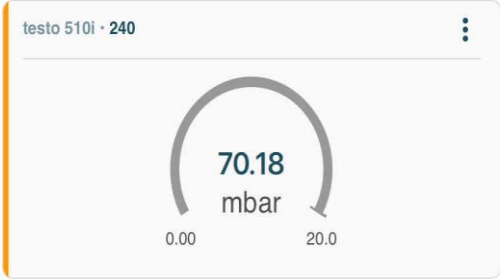
Photo of Unsafe Situation	Defect 1	Defect 2

ECV labelled	Yes	Does ECV operate easily	Yes	Adequate gas isolation	Yes	Suitably sleeved Area Adjacent Meter	Yes	Meter Labelling Correct	
Pipework colour coded /identified from point of Test	Yes	Line diagram at meter (current)	N/A	Clear of combustibles	Yes	Installation cross bonded	Yes	Yes	
Gas pipe supported (Where Visible) from point of Test	Yes	Meter Location	Outside mete box		Flue Dilution (CO <sub>2</sub> ) %	N/A	Air Sample (CO <sub>2</sub> ) %	N/A	
Manometer Make	Testo	Serial No	26884240	Analyser Make	Testo	Serial No	61857248		
Description of work: Boiler service and co2 device check. Tightness test passed but on the sheet you can see a 1.2mb rise. This was due to fluctuation and not a passing ECV. I have sprayed the barrel and all ok.									
Defects					Remedial work required				
No 1	Standing pressure was at 70mb				Adjusted govner now ok				
No 2									
No 3									
No 4									
No 5

<p>The image shows a digital pressure gauge interface. At the top left, it says "testo 510i - 240". In the center, there is a circular gauge with a needle pointing to the value "70.18 mbar". Below the gauge, the scale is marked with "0.00" on the left and "20.0" on the right. The gauge is set against a light gray background with a white border.</p>	
Defect 3	Defect 4	Defect 5
Defect 6	Defect 7	Defect 8
