| Gas Tightness Test | | | | | | | | | |
| Description of work: Tightness test, boiler service and new co alarm installed | | | | | | | | | |

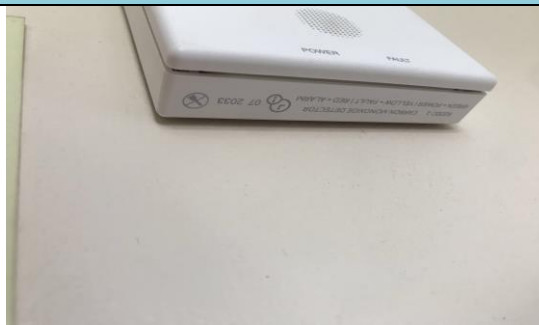
CO Expiry Date

| Gas Tightness Test | | | | | | | | | |
|---|---|---|---|--|---|---|---|---|--|
| Installation (New / Existing / Extension) | Existing | Tightness test duration (mins) | 2 | Actual pressure drop (mbar) | 0 | Yes | 07/2033 | Pass | |
