Gas Tightness Test									
Gas tightness test carried out (Yes / No)	Yes	Total Installation volume (m³)	0.00176	Max allowable pressure drop (mbar)	4	Type of gauge used (water / electronic)	Electric	Tightness test result (Pass / Fail)	
Where was the Test carried out from?	ECV	Let by test duration (mins)	1	Volume smallest occupied space (m³)	29.80	Smell of gas	N/A	Pass	
Scope of work (e.g. IGE/UP/1 or 1A or 1B)	IGE/UP/1B	Stabilisation period (mins)	1	Tightness test pressure (TTP) (mbar)	20	CO Alarm			
						CO Alarm Installed	Date Of Expiry	CO Pass/Fail	
Installation (New / Existing / Extension)	Existing	Tightness test duration (mins)	2	Actual pressure drop (mbar)	0	Yes	09/2025	Pass	
Meter Information									
Meter Location	Externally front of property	Meter room secure	Meter box	Meter room key labelled	Meter box key	Standing pressure at meter (mbar)	23.39	Working pressure at Appliances (mbar)	
Meter size	U6	Meter accessible	Yes	Meter room ventilated	N/a	Working pressure at meter	22.03	20.68

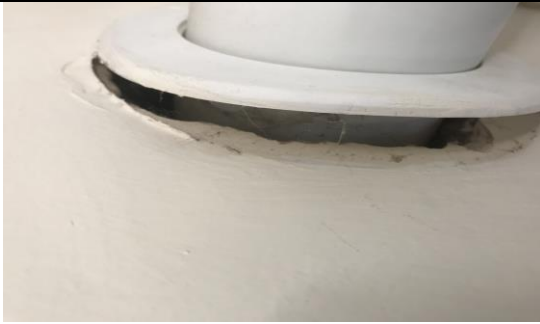
Defect 3

ECV labelled	Yes	Does ECV operate easily	Yes	Adequate gas isolation	Yes	Suitably sleeved Area Adjacent Meter	Yes	Meter Labelling Correct	
Pipework colour coded /identified from point of Test	Yes	Line diagram at meter (current)	N/a	Clear of combustibles	Yes	Installation cross bonded	Yes internally	Yes	
Gas pipe supported (Where Visible) from point of Test	Yes				Flue Dilution (CO ₂) %	N/a	Air Sample (CO ₂) %	N/a	
Manometer Make	Testo	Serial No	N/a	Analyser Make	Testo	Serial No	61857248		
Description of work: Tightness test, boiler service and co alarm tested.									
Defects				Remedial work required					
No 1	Manual vent point at top of heat exchanger has a slight drip on it			Raise a job to replace manual vent point					
No 2	Flue air test point disintegrated when removed on test			Replaced flue air test point on service					
No 3	Wall around flue internally not sealed behind collar			Seal around flue internally

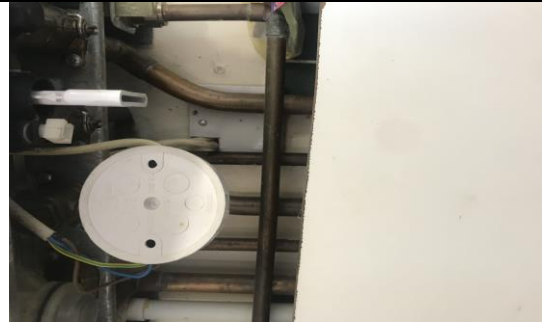
Defect 4

No 4	Electric power supply to boiler needs tidying up			Recommend boiler wired straight from fuse spur into boiler not through a junction box					
No 5	Boiler case controls cover missing			New boiler case control cover needs to be fitted					
No 6									
No 7									
No 8									
Parts used			Part Number		Qty		Declaration of Gas safety: I confirm that all of the work described on this form has been satisfactorily completed in accordance with the current Gas Safety (Installation & Use) regulations, industry standards and procedures.		
Flue air test point cap					1				
Print Name	Sean Moloney		Engineer's Signature
