Gas Tightness Test									
Gas tightness test carried out (Yes / No)	Yes	Total Installation volume (m³)	0.00176	Max allowable pressure drop (mbar)	4	Type of gauge used (water / electronic)	Electric	Tightness test result (Pass / Fail)	
Where was the Test carried out from?	ECV	Let by test duration (mins)	1	Volume smallest occupied space (m³)	25.34	Smell of gas	N/A	Pass	
Scope of work (e.g. IGE/UP/1 or 1A or 1B)	IGE/UP/1B	Stabilisation period (mins)	1	Tightness test pressure (TTP) (mbar)	20	CO Alarm			
						CO Alarm Installed	Date Of Expiry	CO Pass/Fail	
Installation (New / Existing / Extension)	Existing	Tightness test duration (mins)	2	Actual pressure drop (mbar)	0	Yes	07/2033	Pass	
Meter Information									
Meter Location	Externally rear of property	Meter room secure	Meter box	Meter room key labelled	Meter box key	Standing pressure at meter (mbar)	22.70	Working pressure at Appliances (mbar)	
Meter size	U6	Meter accessible	Yes	Meter room ventilated	N/a	Working pressure at meter	20.71	21.22

Tightness Test Carried out from this Valve 'Label'

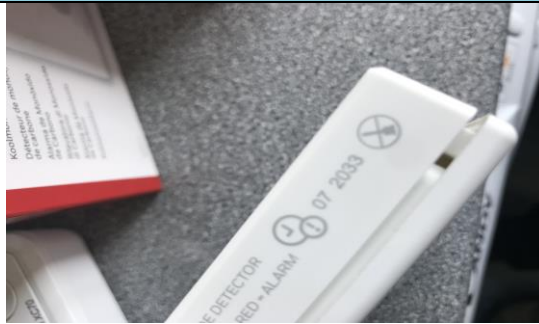
Defect 1

ECV labelled	Y	Does ECV operate easily	Yes	Adequate gas isolation	Yes	Suitably sleeved Area Adjacent Meter	Yes	Meter Labelling Correct	
Pipework colour coded /identified from point of Test	Yes	Line diagram at meter (current)	N/a	Clear of combustibles	Yes	Installation cross bonded	Yes internally	Yes	
Gas pipe supported (Where Visible) from point of Test	Yes				Flue Dilution (CO <sub>2</sub> ) %	N/a	Air Sample (CO <sub>2</sub> ) %	N/a	
Manometer Make	Testo	Serial No	N/a	Analyser Make	Testo	Serial No	61857248		
Description of work: Tightness test, boiler service and new co alarm installed as existing one out of date before next service									
Defects					Remedial work required				
No 1	Flue terminal looks to close to extract fan grill				Recommend moving extractor fan grill further away from flue terminal or a flue plume kit fitting				
No 2	Cover hinges broken on front panel				Replace hinges to front panel
