## **Flat Roof Pre-access Hazard Identification Report**

### **01.006 ENERGY INNOVATION CENTRE (EIC)**

Date undertaken: 25<sup>th</sup> October 2021

Building 01.006 EIC, Central Campus

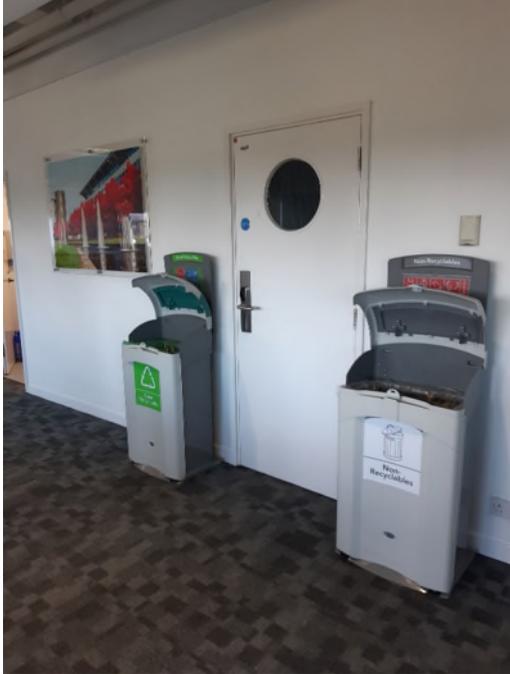
4<sup>th</sup> floor, door leading to roof access

- 3.1 A roof access permit will need to be requested with suitable RAMS at least 72 hours before it is required for any planned work. If approved, the permit is issued to the permit requester via email, usually the day before it is required. If a roof access card is required, the Permit Office issues instructions to the permit requester to say how this should be collected. Contractors should sign in on site as agreed with their Contract Supervisor. For this roof you will require; a roof access permit and a Salto roof access card to open the door from the office on 4<sup>th</sup> floor and the roof door (see photos).

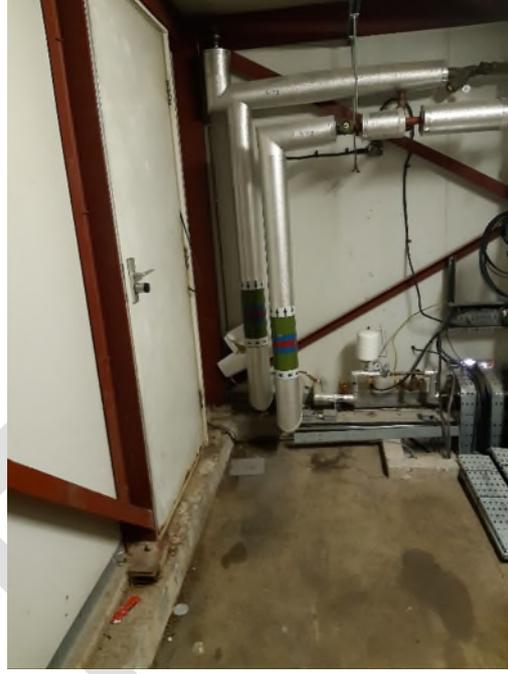
Roof access door at top of stairs

- 3.3 Take the lift or the stairs on to the fourth floor. You will arrive in an open plan office where you may be asked to sign in and present your permit and reason for being there. You will need to proceed to the left of the central section of the office where you will see WCs and a door with a round, glass porthole (see photo). Use the Salto card to open this door and proceed up the metal stairs where you will find a white door with a Salto lock. The roof door is opened with the Salto access card. You will need to step over the raised door jamb onto the roof

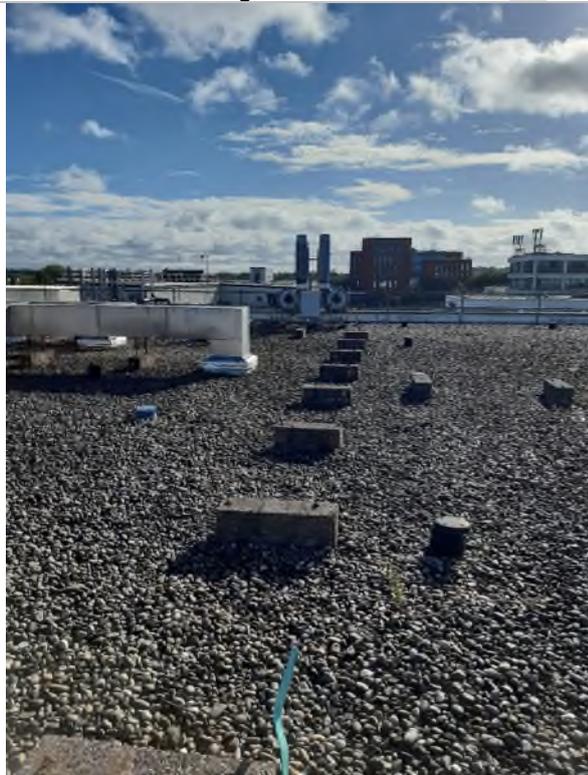
9.1. **Slips, trips and falls around the site:** The main roof is laid to pebble and has various plant including AHUs, chillers and fume cupboard stacks so there are a lot of trip hazards in the form of uncovered cable trays, ducts, pipework, lightning strips and ventilation outlets. The edge barrier supports provide an additional trip hazard.

Main roof with trip hazards

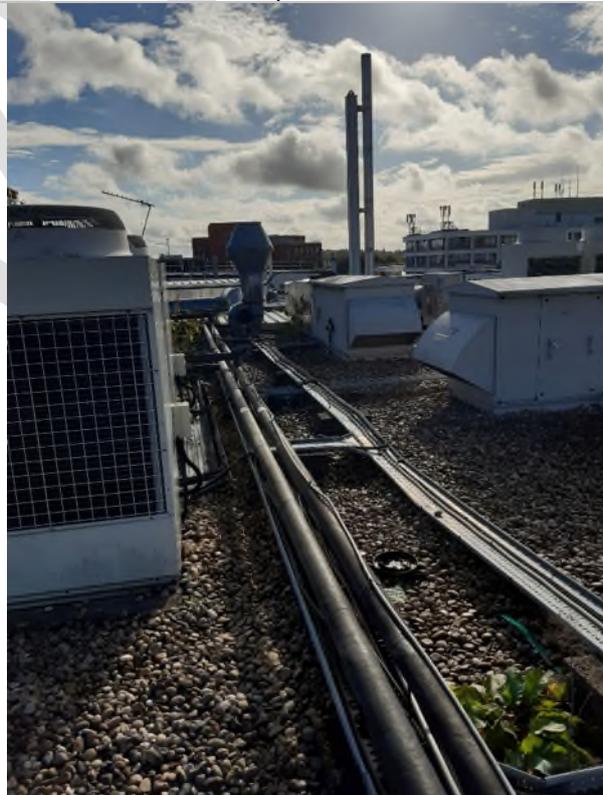
Main roof: trip hazards – uncovered cable trays

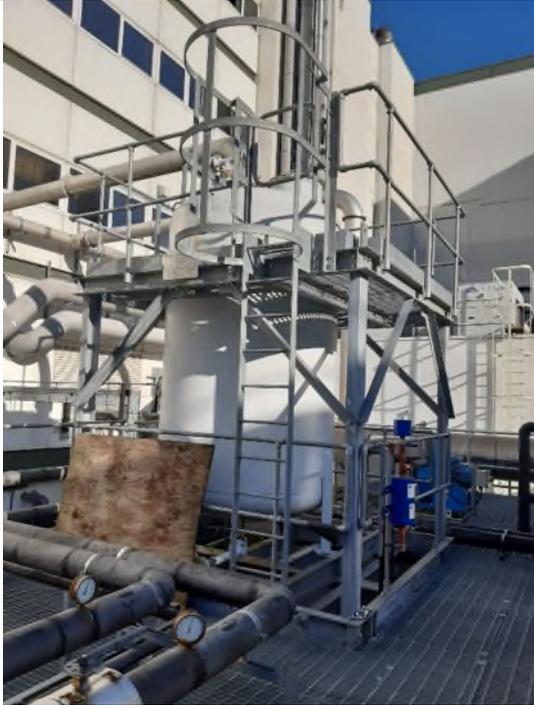
9.4. **Falls from height:** On the lower roof (accessed by metal stairs outside in the loading bay area) there is a fixed, hooped, metal access ladder to access plant on an upper mezzanine area. Adequate consideration must be given for transporting tools, equipment and materials onto the roof while maintaining three points of contact on the ladders. There is another fixed ladder to the chiller plant on an adjacent roof but this should not be used to gain access to this as there is an internal door (on the 2<sup>nd</sup> floor) to access this roof.

External lower roof area with fixed ladders

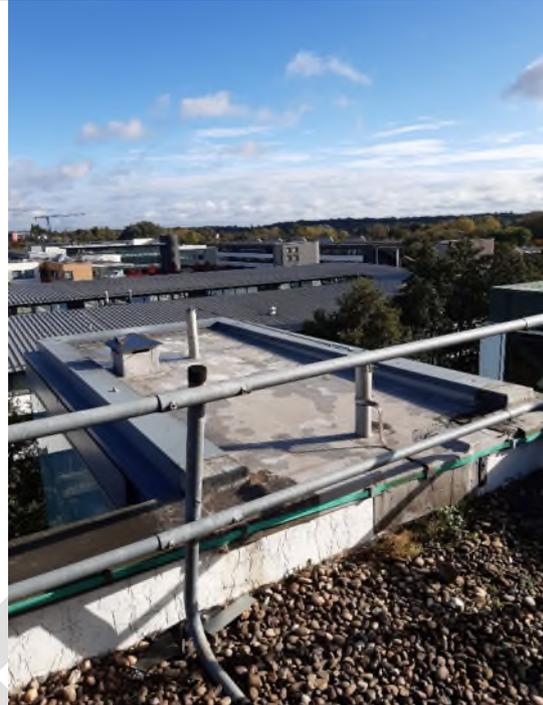
9.3. **Falls from height:** There is a small, rectangular section of roof on the front aspect of the building that has a man safe (latchline) system, but no edge protection. **Access to this roof requires an additional risk assessment and competence in use of personal fall restraint equipment.**

Roof section with man safe system and no edge protection

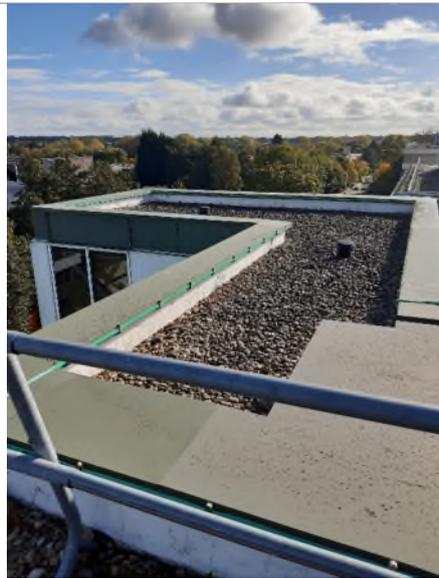
9.2. **Falls from height:** The main roofs are fully edge protected however there is a small L-shaped section of roof on the front, right corner aspect of the building which has no edge protection or other fall prevention/restraint systems and can only be accessed by climbing over the edge protection on the main roof. **Additional fall prevention measures would need to be risk assessed in order to access this roof, i.e. if access to check the lightning protection strip is required.**

Roof section with no edge protection

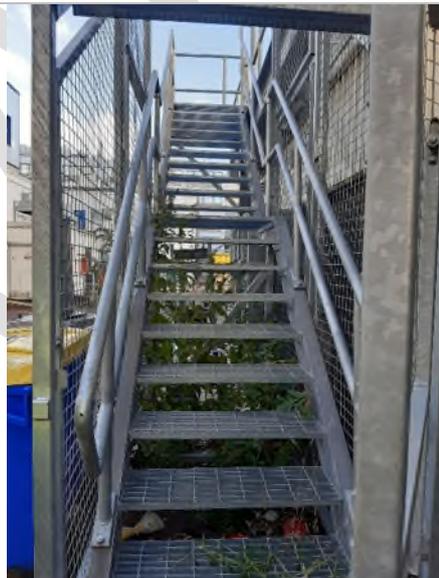
9.5. **Unauthorised access:** At the time of the survey the gate to the lower roof in the external loading bay area was unlocked therefore allowing unauthorised access onto the roof.

External stairs to external plant area
