Flat Roof Pre-access Hazard Identification Report

01.007 PHYSICAL SCIENCES

Building 01.007 Physical Sciences, Central Campus

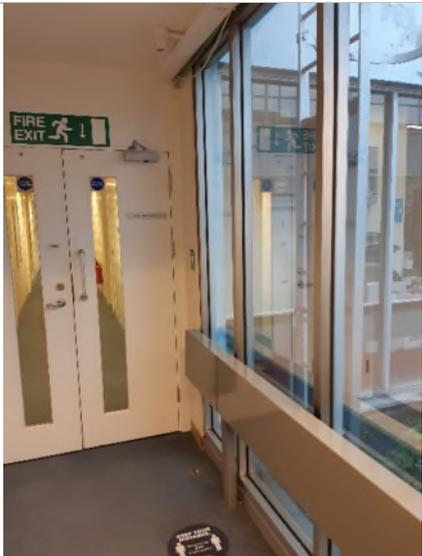
<p>First floor double doors (roof ladder on right)</p>	<p>First floor internal access doorway</p>

- 3.3 Proceed up the stairs to first floor (a lift is available if you need it). Once at the top of the stairs turn right and right again through the double doors (you will see the fixed vertical ladder through the window on your right) (see photo). You will find a Co-door controlled single leaf door to a common room on your right (see photo). Key in the code provided and access through the door. There is a door to the right which leads onto a roof terrace (this should be unlocked).

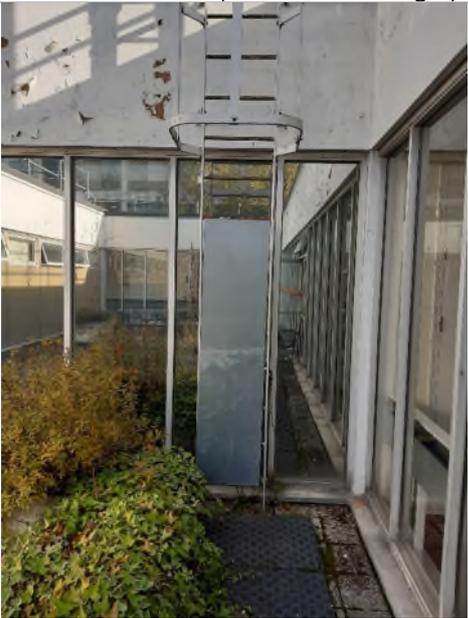
<p>Roof access ladder</p>	<p>Change in roof levels & missing guard rail</p>

- 3.4 Once on the terrace, you will see a fixed vertical hooped ladder to your right with a ladder guard (see photo). Use the Salto card to unlock the geo lock and remove the guard to access the ladder to the main roof. The ladder guard and lock must be secured and checked before leaving the roof area.

9.2 Access to the roof is via a fixed metal hooped vertical ladder. Adequate consideration must be given for transporting tools, equipment and materials onto the roof while maintaining three points of contact on the ladder.

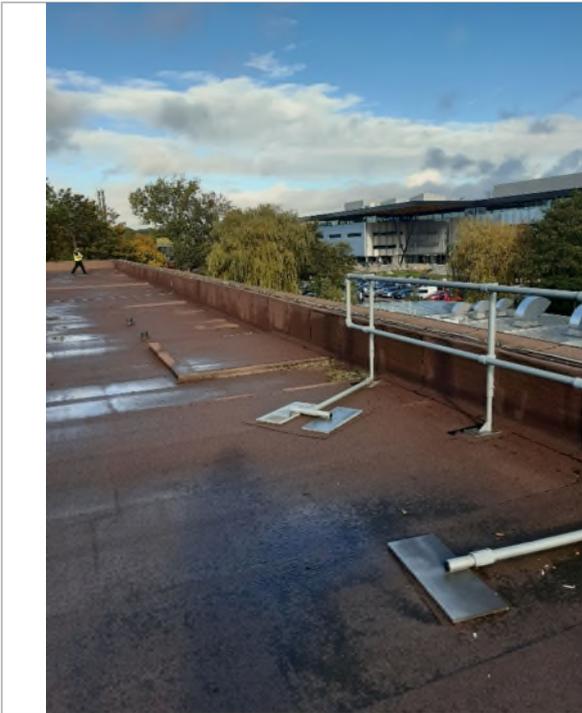
9.1 Falls from height; the main roof has a low parapet wall on all sides with edge protection installed to the Northeast side, rear and part of the front. There is no guardrail to a large section of the front and Northwest side of the building (see photo). There is also a gap in the edge protection on the Northeast side between the two levels and the lightning protection strip runs outside of the guardrail (see photo). Consideration should be given to the potential for falls from height in terms of operatives, materials and tools, especially in high winds.

Missing guard rail

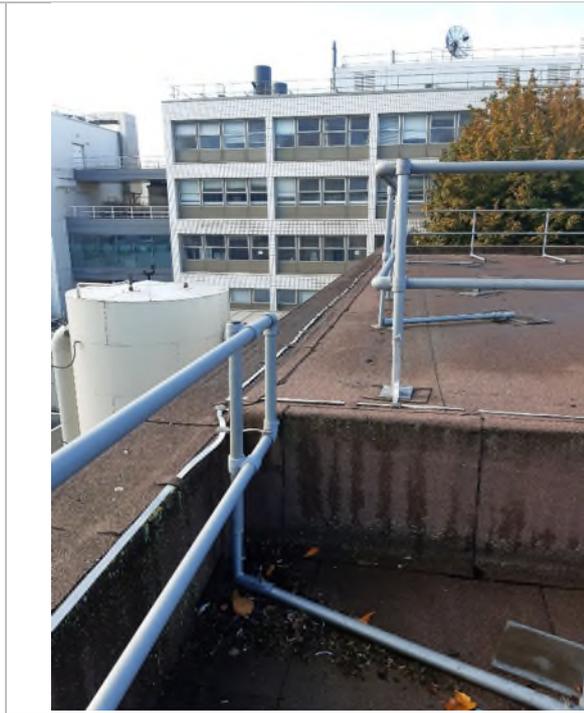
Gap in edge protection
