## **Flat Roof Pre-access Hazard Identification Report**

**01.018 RAMPHAL**

Date undertaken 25<sup>th</sup> October 2021

Building 01.018 Ramphal, Central Campus

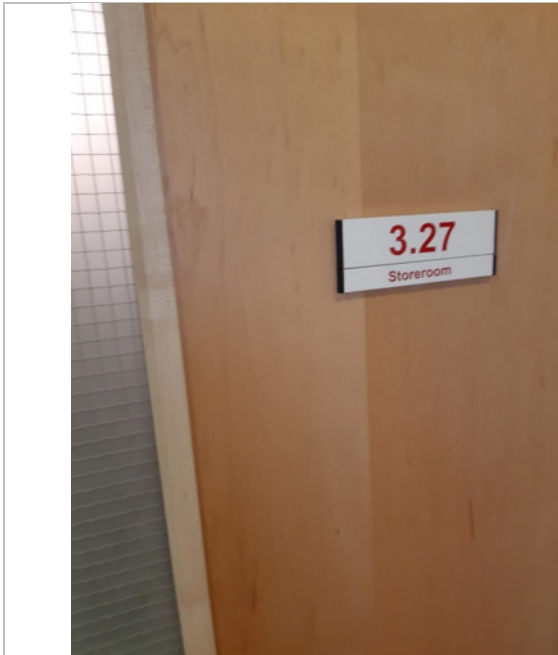
Room 3.27 leading to roof ladder/stairs

4.3. Proceed up the stairs to the third floor (a lift is available on the right of the entrance if you need it). Once at the top of the stairs turn right and right again and you will see a door marked 3.27. You will need to find a member of administrative staff nearby and show them your permit to unlock this door as it's a storeroom. There is a fixed metal staircase in the corner of the room which leads up to the roof door (see photo). The roof door is opened with the Salto access card. Care should be taken when passing through the doorway as it is not full height and there is an immediate step down onto the roof.

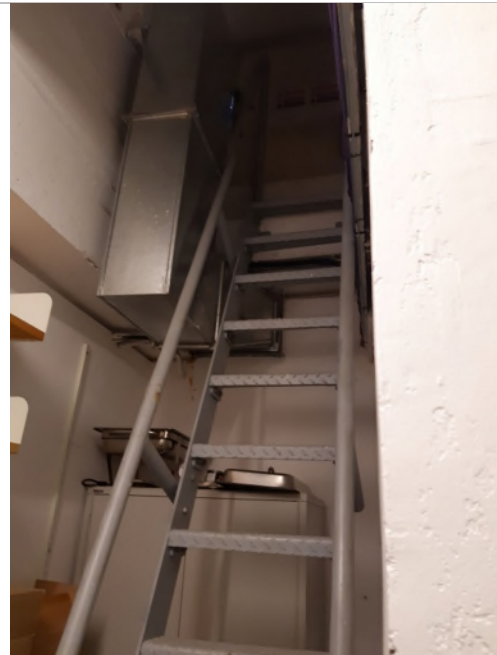
Fixed steps in 3.27 to roof door

9.6 Bump hazards: Access to the roof is via open metal stairs to a half height door. Care must be taken when passing through the doorway as it may be a bump hazard.

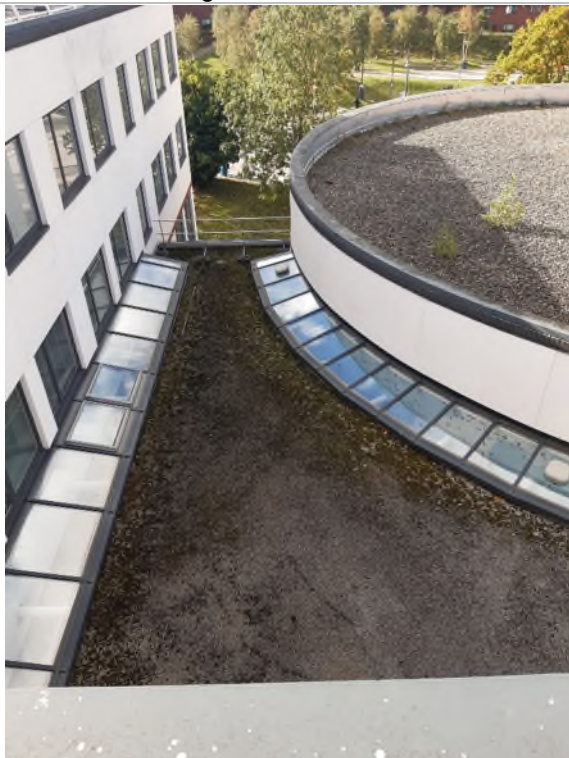
View from main roof to atrium and lecture theatre roofs

9.2. Slips, trips and falls around the site: The atrium roof can only be accessed via windows on the second floor. The windows open next to the edge protection on one side and roof lights on the other so this would not be practicable without a specific risk assessment and controls. **You must not access this roof without first discussing risks and control measures with your University project manager. The permit application must specify if access to this roof is required.**

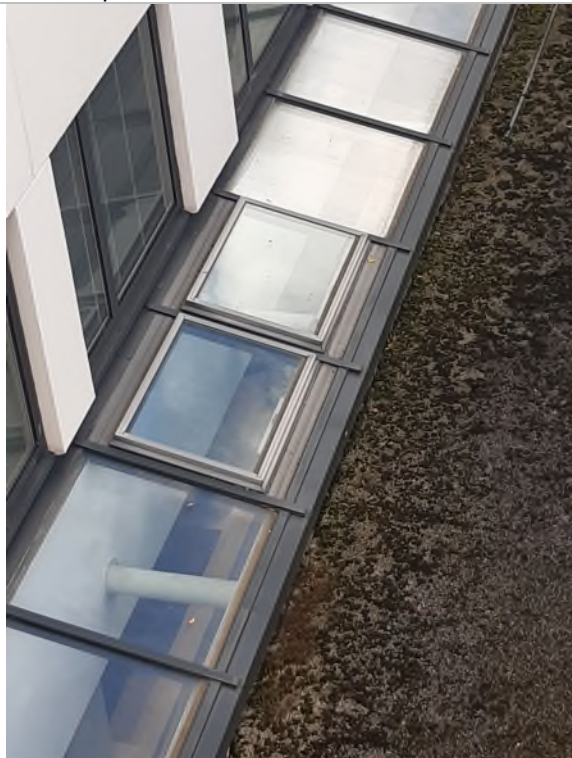
Roof lights and smoke vents on atrium roof

9.4 Falls through fragile surfaces: The atrium roof has glass roof lights to two sides. It is not known if the glass is toughened so they shouldn't be walked on or have materials or equipment placed on them.

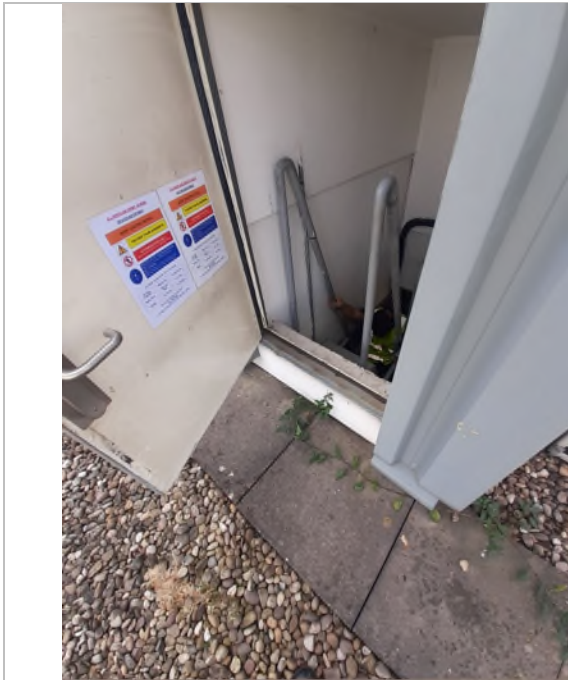
Roof access door and steps

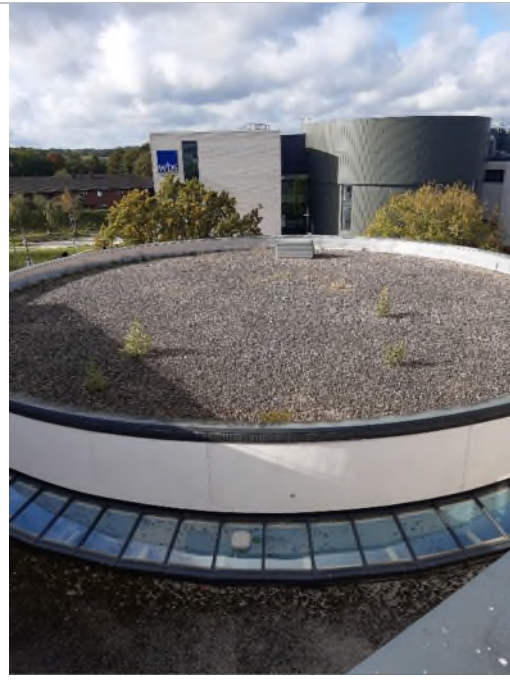
Lecture theatre roof (viewed from main roof)

9.5 Falls from height/falls through fragile surfaces: there is no internal access onto the lecture theatre roof and no guardrail on this roof. If access was required via the atrium roof, i.e. by use of a ladder, special consideration should be given to the proximity to roof lights on one side and the guardrail on the other, as well as the lack of edge protection once on the roof. **You must not access this roof without first discussing risks and control measures with your University project manager. The permit application must specify if access to this roof is required.**
