Flat Roof Pre-access Hazard Identification Report

01.027 SCIENCE BLOCK A

Date undertaken 31st January 2024

University of Warwick,
Coventry,
CV4 7AL

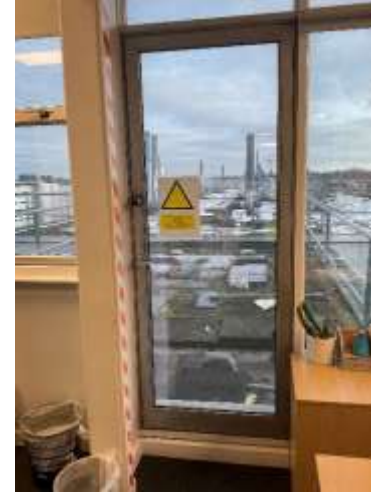
B.505 Office roof access door (Salto)

3.5 Once in the office, use your Salto roof access card to open the door straight ahead of you to exit out onto the roof. Please ensure that this door is kept closed and secured at all times.

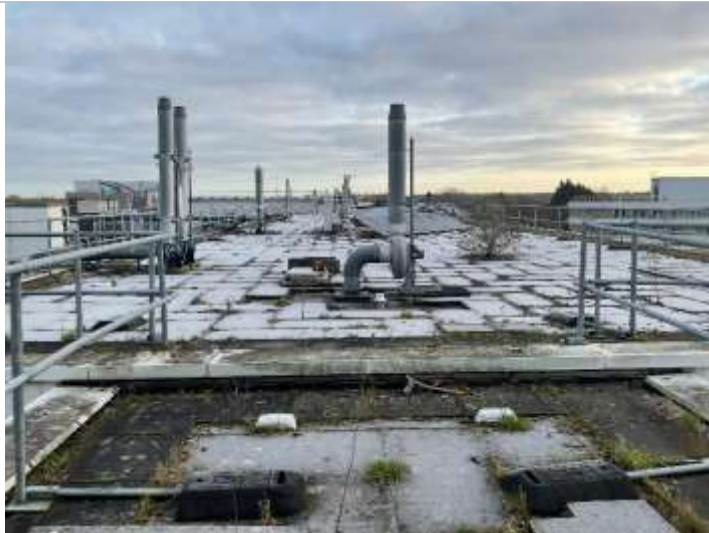
Roof overview, trip hazard edge protection weights

9.7 Some of the edge protection supports along with weights are within the walkways. Care should be taken to avoid these as they present a trip hazard.

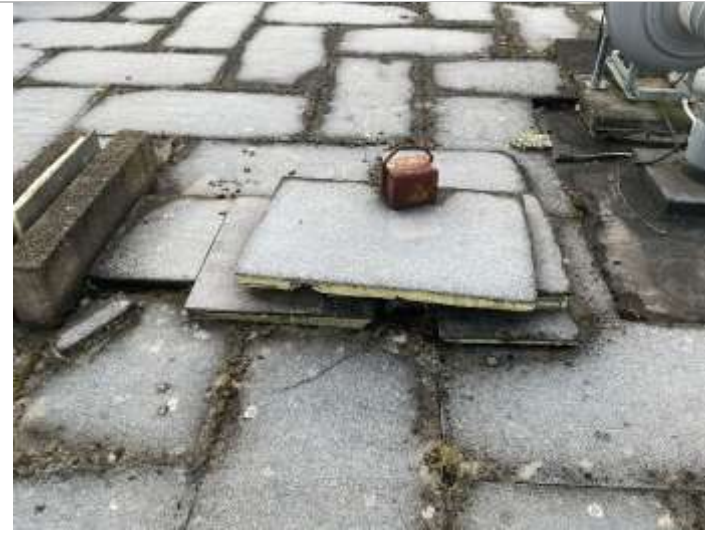
Loose slabs causing trip hazard along with resulting holes at floor level

9.2 Slips, trips and falls around the site. There are no set out walkways for this roof, it is open plan. The roof flooring comprises slabs and there are areas where slabs are not aligned properly with the floor level or have been left stacked, after removal so present a trip hazard.

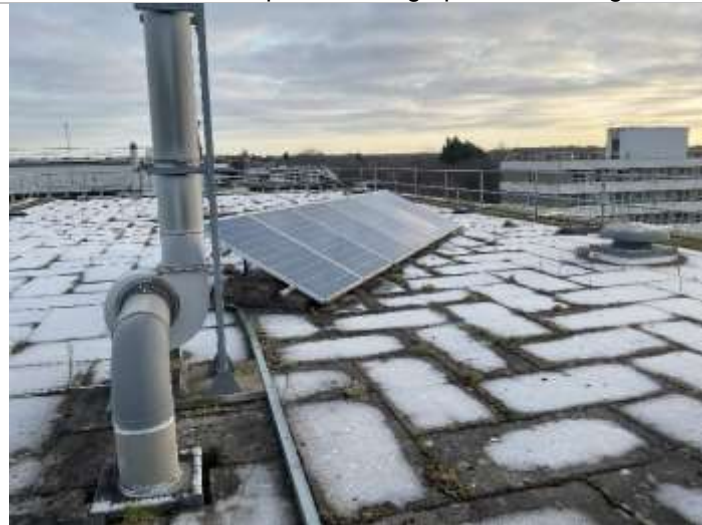
PV Panels

9.6 Falls and trips onto PV Panels, cable trays and other plant. Under no circumstance should the PV panels or any other plant, be stood upon.

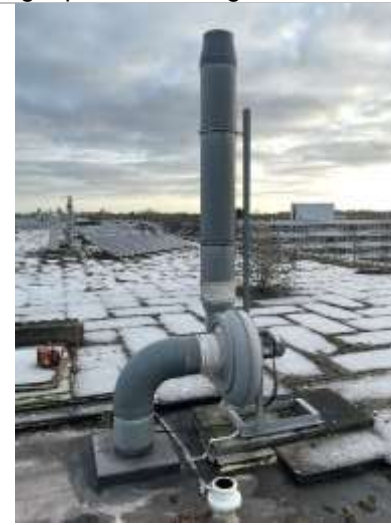
Typical Chemistry/Engineering flue

9.1 Noxious Gasses – Before proceeding onto this roof, authorisation and prior arrangement must be made via the ‘Deputy Technical Services Facilities Manager, Chemistry’ and ‘Technical and Facilities Manager, School of Engineering’ as there are flues that have the potential to vent fumes hazardous to health. The prior arrangement will ensure these are ‘switched off’ during your time on the roof. **Please check in with one of them on site before accessing the roof.**
