Flat Roof Pre-access Hazard Identification Report

01.278, 01.279, 01.280, 01.281 BLUEBELL RESIDENCES 1-4

Date undertaken 1st March 2023

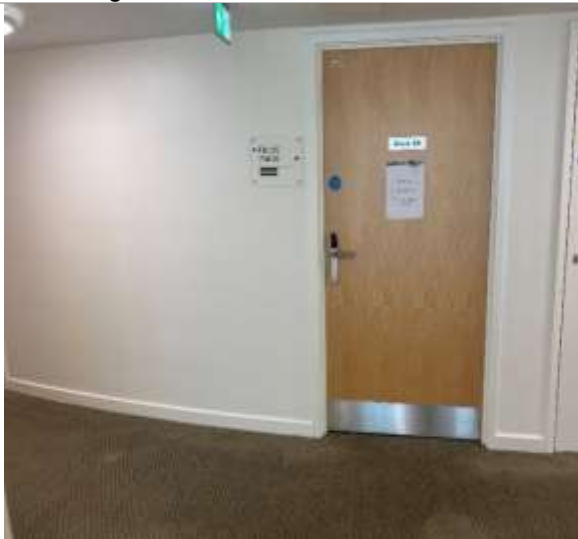
Access the roof space through the storeroom door. This is Salto access, and this room must be kept locked at all times.

3.5 When you have entered the building enter the lift and go up to the top floor. Access the roof ladder via the storeroom door (as pictured). Please make sure this door is locked whilst you are on the roof. Climb the fixed vertical ladder, present the Salto card to the lock on the hatch, and access the roof space through the Salto roof hatch.

3.6 When leaving the roof area, you will need to resecure this door by presenting your Salto card to the lock and turning the barrel to lock the door. Please be aware this will not lock automatically. Please make sure the roof hatch and the storeroom door is left secure and locked.

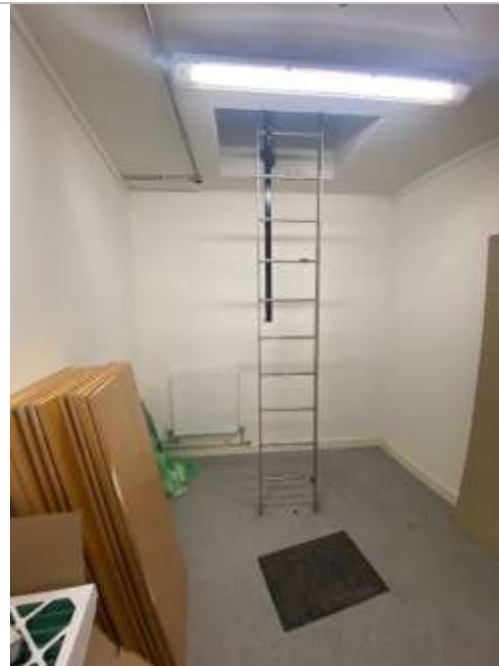
Access the roof hatch via the access ladder.

9.2 Access through the roof hatch is restricted and narrow so adequate consideration must be made for tools, equipment, and materials to be moved to the roof internally or externally. The galvanised steel ladder is fixed and ensures 3 points of contact can be maintained.

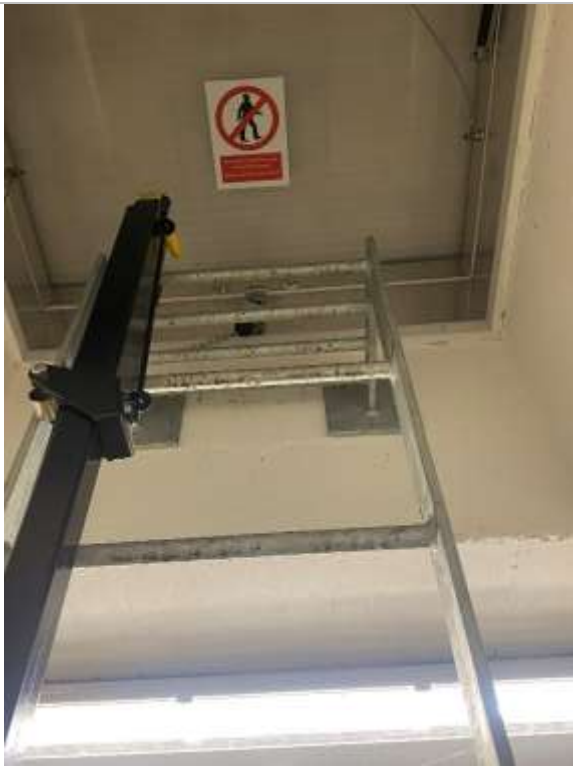
Go up through the roof hatch on to the roof space.

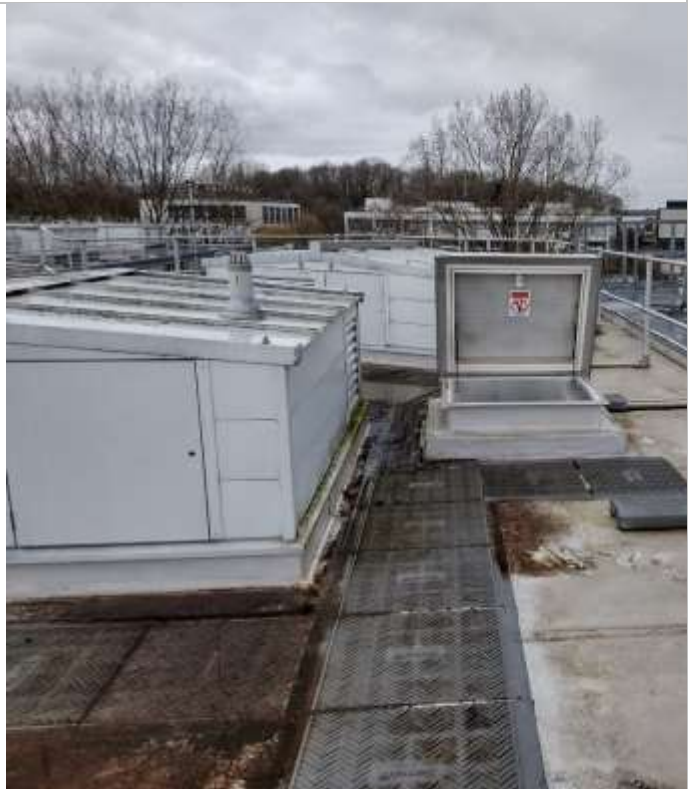
The roof space has designated walkways.

9.3 The pathways on the roof are well laid out but deviation off the matted areas could result in slips on the roof surface in cold or wet weather conditions and the proximity of plant may present awkward obstacles to work around.

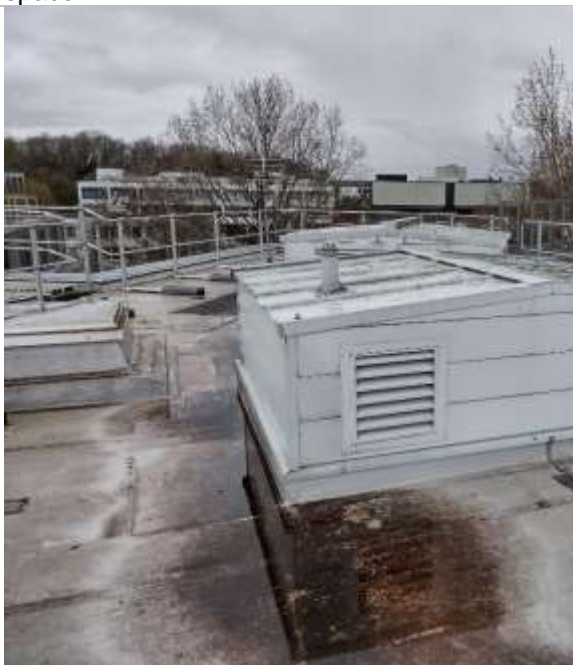
The roof space benefits from edge protection.

7.3 Falls from height: Whilst there is edge protection in place, consideration should be given to the potential for falls from height in terms of operatives, materials and tools, especially in high winds.

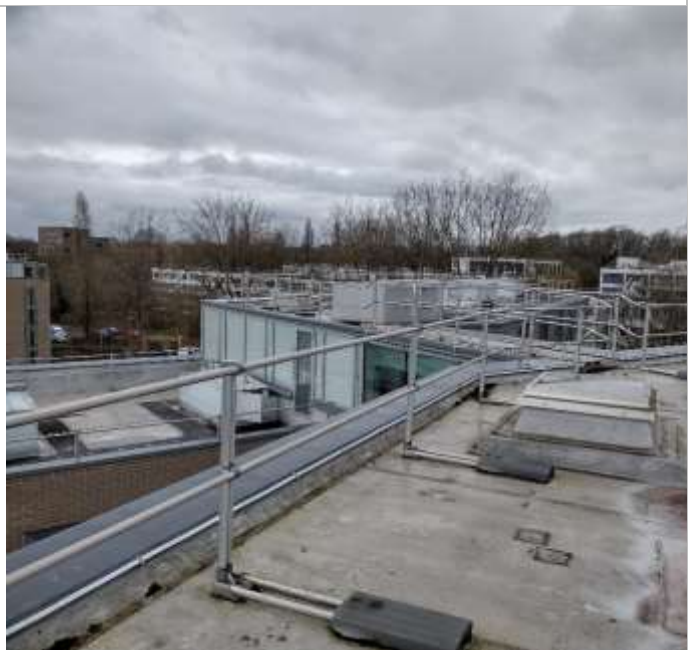
Skylights and hatches situated on the roof space.

9.1 Falls and trips onto skylights and other plant. Under no circumstance should plant equipment or skylights be stood upon.
