### Flat Roof Pre-access Hazard Identification Report

#### THE OCULUS

Date undertaken 19th January 2026 10am

Building 01.366 The Oculus, Central Campus

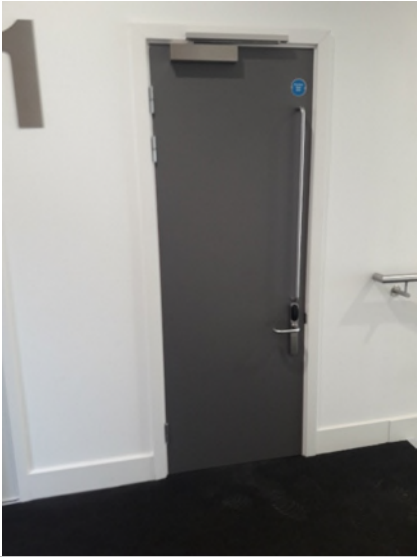
| <p>First floor internal access door</p> | <p>Maintenance side staircase</p> |

- 4.3. Proceed up the stairs to first floor (a lift is available if you need it). Once at the top of the stairs there are two options for access to the roof and are the same on the North and South sides. Follow the central curved wall around to the left or right and you will find a Salto controlled single leaf door (see images). Swipe the Salto fob and access through the door.

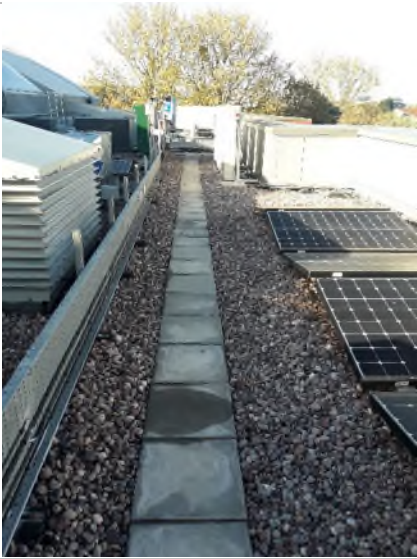
| Flat roof walkway and plant | Flat roof walkway and plant |

8.1. Slips, trips, and falls around the site. The walkways are very well laid out, including gantries over plant. However, should the need arise to venture off the access pathway, the ballast loose stone may be unstable under foot and the proximity of other plant may present awkward obstacles to work around.

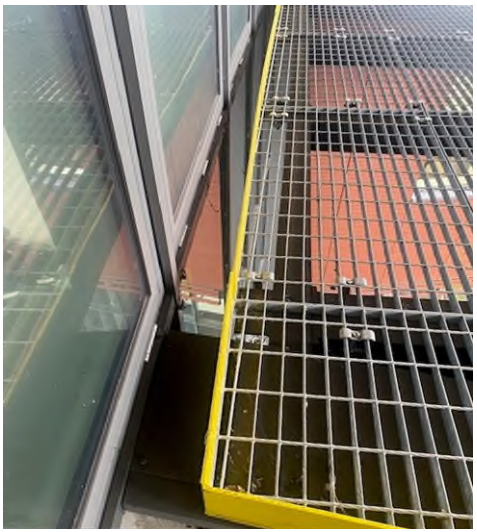
8.2. There is a gap larger than 100mm between the grated walkway and the building, which has an approx. 40ft drop. There is a small yellow toe board at present and angle brackets have been recently added to reduce the gap between the walkway and windows. There are signs on the doors to make operatives aware.

| Gap of over 100mm | Walkway with new angle brackets fitted 2026 |

10.2. There is a gap larger than 100mm between the grated walkway and the building, which has an approx. 40ft drop. There is a small yellow toe board at present and angle brackets have been fitted to reduce the gap. There are signs on the doors to make operatives aware.
