## **Flat Roof Pre-access Hazard Identification Report**

### **WESTWOOD – MUSIC CENTRE**

Date undertaken 11<sup>th</sup> May 2023

Building 03.007 Music Centre, Central Campus

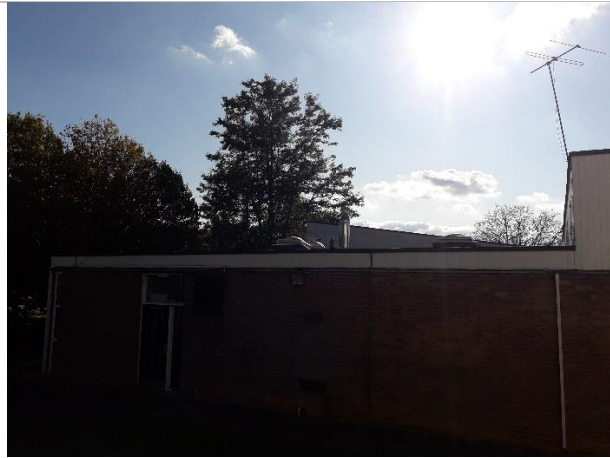
7.1 Slips, trips and falls around the site. There are roof protrusions; roof light upstands, vegetation and SVP exhausts/vents. Pitched roofs have an increased likelihood of causing falls. Extra care should be taken.

Roof protrusions (Sky light and exhausts/vents)

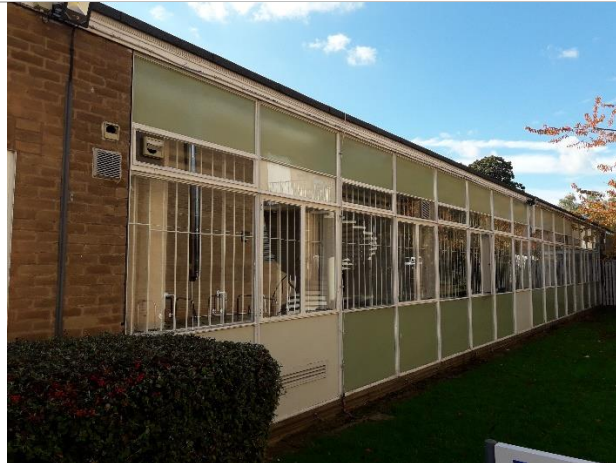
7.3 Falls from height: There is no edge protection in place, consideration should be given to the potential for falls from height in terms of operatives, materials and tools, especially in high winds.

No edge protection

9.1. There is no permanent edge protection to the roof, if works are being undertaken on the roof, within m of the edge temporary edge protection must be installed. Consideration should be given to the potential for falls from height in terms of operatives, materials and tools, especially in high winds. There are also pitched section of the roof which creates an increased risk of slips and falls.

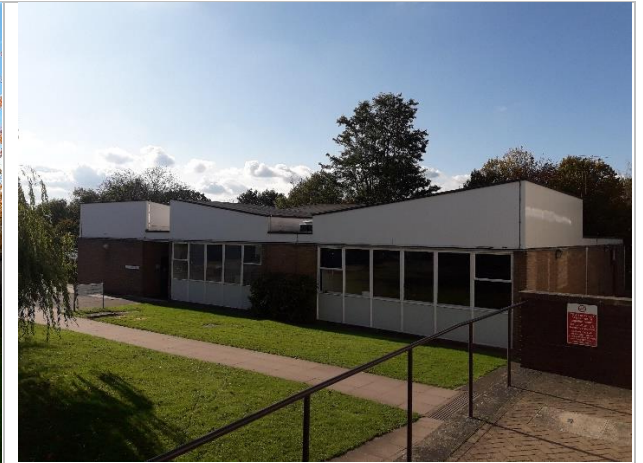
Pitched roof
