## **Flat Roof Pre-access Hazard Identification Report**

### **03.013 Westwood Post Room**

Date undertaken 22nd October 2019

Building 03.013 Post Room, Westwood Campus

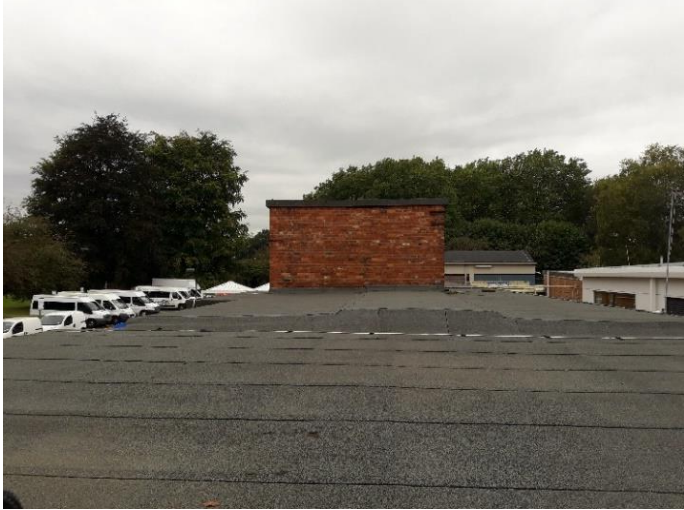
Roof view & no edge protection

9.2. Falls from height: There is no edge protection or latch line systems in place so consideration should be given to the potential for falls from height in terms of operatives, materials and tools, especially in high winds.

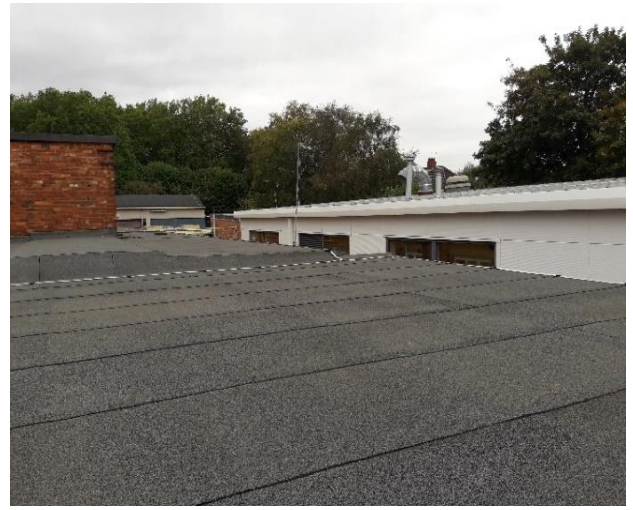
Lightning conductor rod

9.1 Falls, slips and trips. A lightning conductor cable and gas pipe runs at floor level. Caution and care must be taken to avoid these.

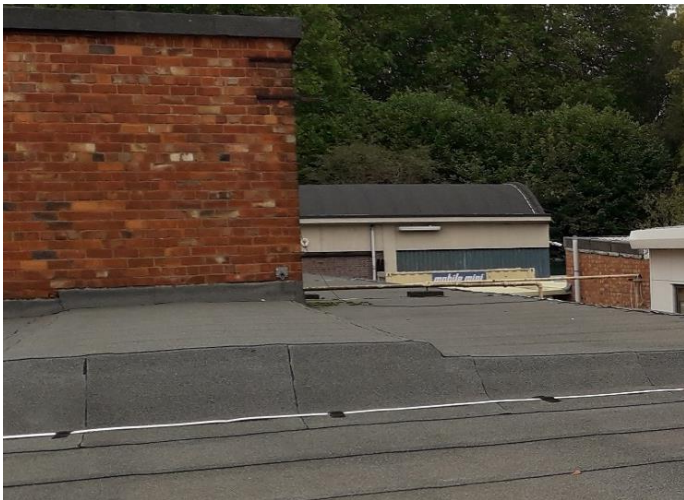
Gas pipes

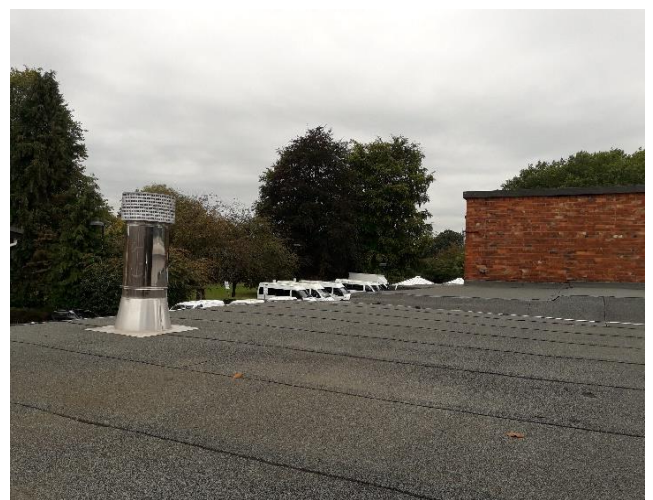
Boiler flue

9.3 Flue from boiler may become hot and release noxious fumes.
