**PRT**  
HEATING LTD  
COMMERCIAL | INDUSTRIAL | DOMESTIC

| Gas Tightness Test | | | | | | | | | |
| Description of work: Boiler service and cp12 | | | | | | | | | |

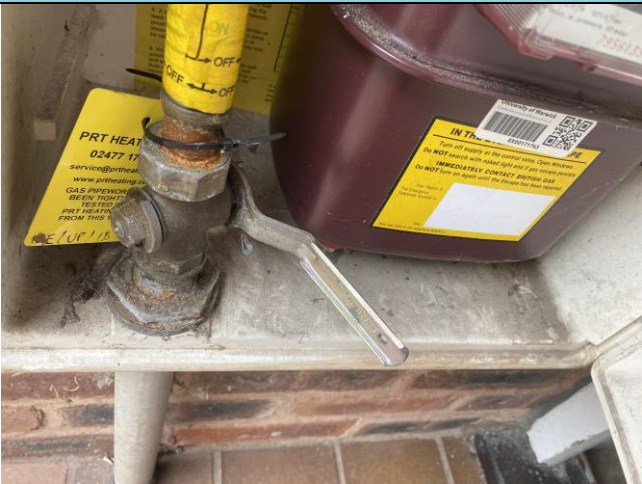
| Photo of Unsafe Situation | Defect 1 | Defect 2 |

| Gas Tightness Test | | | | | | | | | |
|---|---|---|---|---|---|---|---|---|--|
| No 1 | ECV doesn't shut into off position when filling pushing down | | | | New ECV to be installed this would require a dig and squeeze off. | | | | |

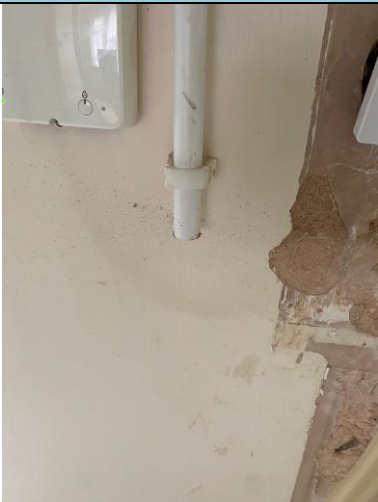
| Gas Tightness Test | | | | | | | | | |
|---|---|---|---|---|---|---|---|---|--|
| No 2 | Condense open ended as new kitchen being installed | | | | Kitchen fitters will install this into waste | | | | |
