**PRT**  
HEATING LTD  
COMMERCIAL | INDUSTRIAL | DOMESTIC

| Gas Tightness Test | | | | | | | | | |
|---|---|---|---|---|---|---|---|---|--|
| Description of work: Boiler service and co device check | | | | | | | | | |

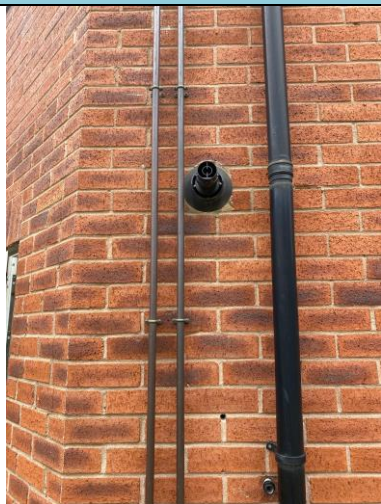
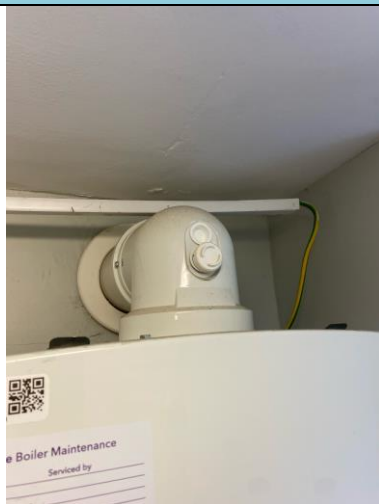
Appliance Flue Termination

| Gas Tightness Test | | | | | | | | | |
|---|---|---|---|---|---|---|---|---|--|
| No 1 | Terminal is poor sitting no damage to gas pipe | | | | There's no damage to gas pipe but I've made turret sit straight to avoid damaging gas pipe | | | | |

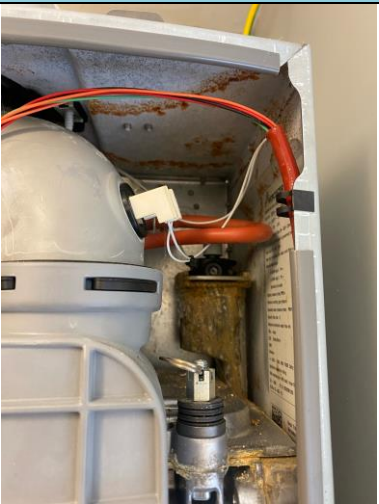
| Gas Tightness Test | | | | | | | | | |
|---|---|---|---|---|---|---|---|---|--|
| No 2 | Heat exchanger cleaned this is the 2nd time in 1 year and hasn't made a difference. | | | | Recommend new boiler as heat exchanger not in the best condition wouldn't be cost effective to replace heat exchanger itself | | | | |
