| Gas Tightness Test | | | | | | | | |
| Description of work: Tightness test, boiler service and co alarm tested | | | | | | | | |

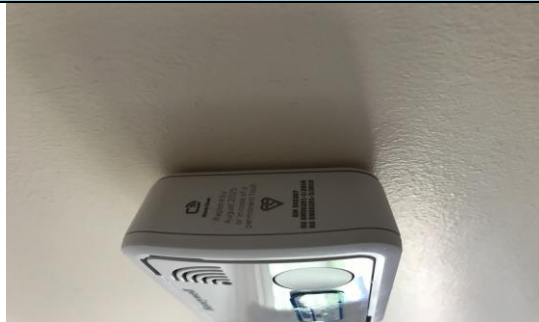
CO Expiry Date

| Gas Tightness Test | | | | | | | | |
|---|---|---|---|---|---|---|---|---|
| Installation (New / Existing / Extension) | Existing | Tightness test duration (mins) | 2 | Actual pressure drop (mbar) | 0.6 | Yes | 08/2025 | Pass |

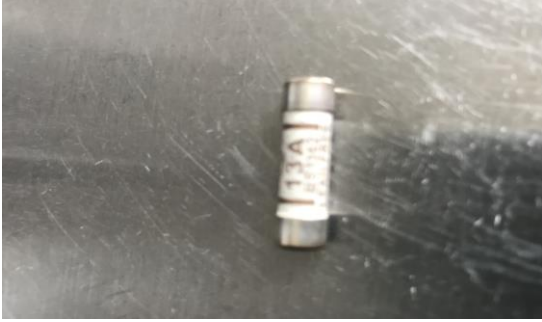
| Photo of Unsafe Situation | Defect 1 | Defect 2 |

| Gas Tightness Test | | | | | | | | |
|---|---|---|---|---|---|---|---|---|
| No 1 | 13 amp fuse in fuse spur to boiler | | | Swapped for a 3 amp fuse | | | | |
