| Gas Tightness Test | | | | | | | | | |
| Description of work: Serviced boiler | | | | | | | | | |

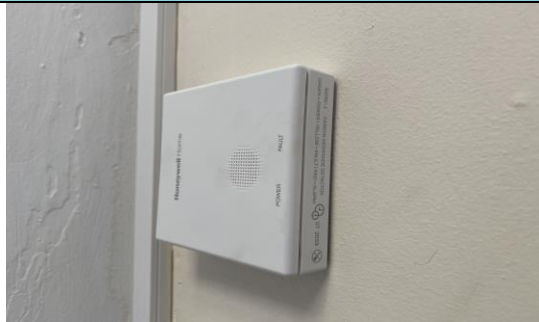
CO Expiry Date

| Gas Tightness Test | | | | | | | | | |
|---|--|---|---|--|--|---|---|---|--|
| Installation (New / Existing / Extension) | Existing | Tightness test duration (mins) | 2 | Actual pressure drop (mbar) | 0 | Yes | 07/2033 | Pass | |

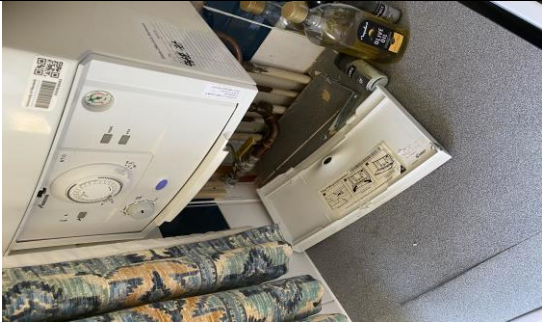
| Photo of Unsafe Situation | Defect 1 | Defect 2 |

| Gas Tightness Test | | | | | | | | | |
|---|--|---|---|--|--|---|---|---|--|
| No 1 | Front cover of boiler that hides the controls broken off | | | | | | | | |
