| Gas Tightness Test | | | | | | | | | |
| Description of work: Service | | | | | | | | | |

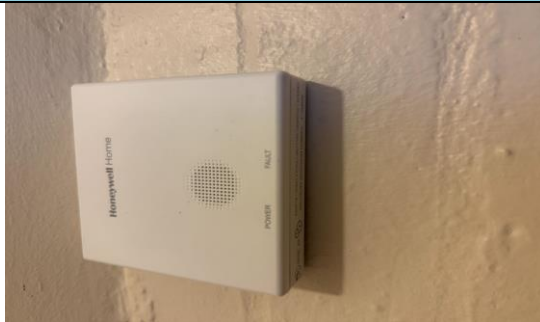
CO Expiry Date

| Gas Tightness Test | | | | | | | | | |
|---|---|---|---|--|---|---|---|---|--|
| Installation (New / Existing / Extension) | Existing | Tightness test duration (mins) | 2 | Actual pressure drop (mbar) | 0 | Yes | 07/2035 | Pass | |

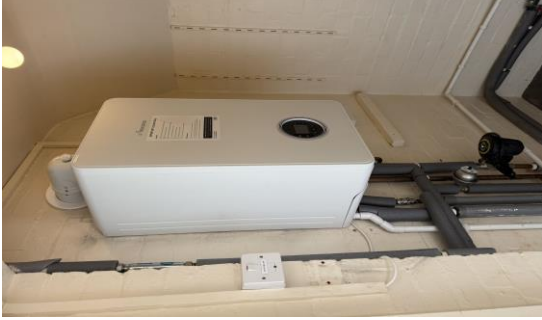
| Photo of Unsafe Situation | Defect 1 | Defect 2 |

| Gas Tightness Test | | | | | | | | | |
|---|---|---|---|--|---|---|---|---|--|
| No 1 | Rf controller not working | | | | Worcester engineer to visit under warranty on Friday to fix this | | | | |
