Flat Roof Pre-access Hazard Identification Report

01.200 ROOTES RESIDENCES A-C

Date undertaken 18th October 2023

Building 01.200 Rootes Residences A-C, Central Campus

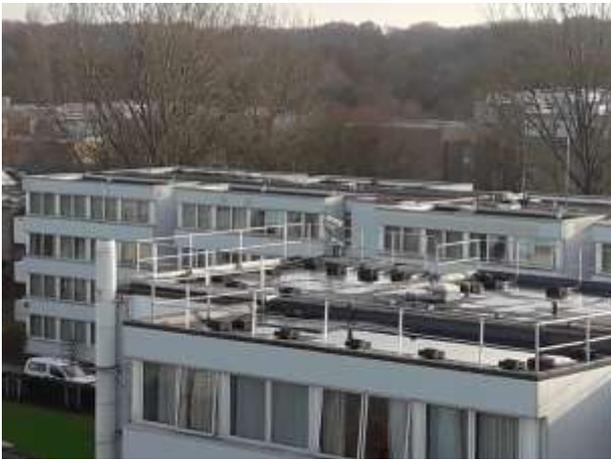
External Roof

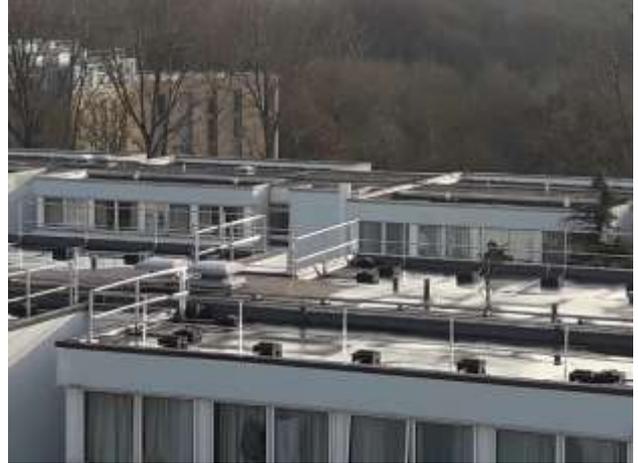
External Roof

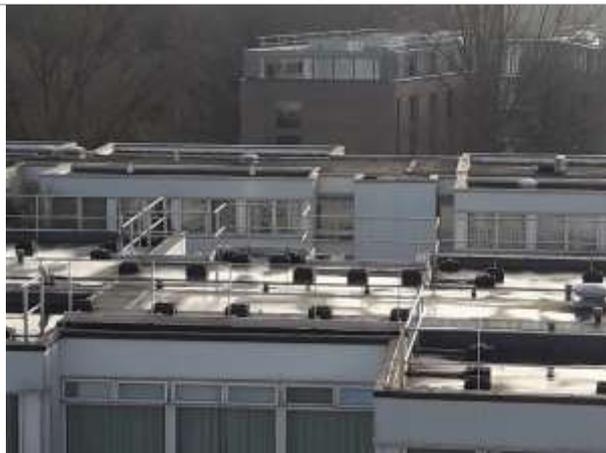
External roof staging area

3.6 Access via step ladder and use the Philips screwdriver to unscrew the hatch. The telescopic ladder can then be pulled down. Once you reach the top use the Salto fob to open the lock to the roof hatch which can then be slid back to access the roof staging area.

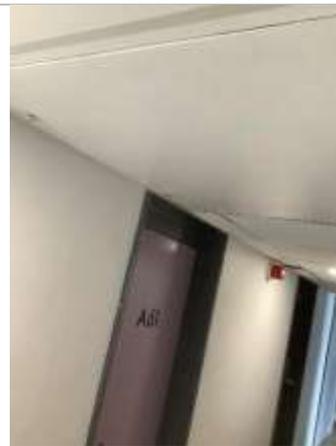
Ceiling Hatch Location

3.5 The ceiling hatch can be found outside of Room A61.

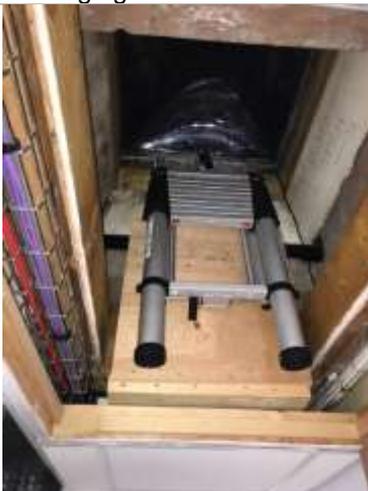
Telescopic Ladder

9.2 The roof hatch is accessed via your own stepladder and there is a vertical fixed telescopic pull-down ladder.

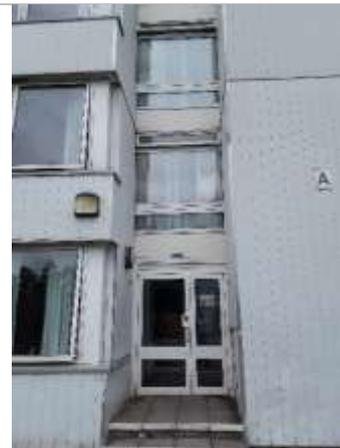
Entrance Block A

3.3 When you reach the Rootes Residences A-C, you will need to approach from the West side and access the building through the A Block entrance door.
